AUCHTERMUCHTY CONSERVATION AREA APPRAISAL AND MANAGEMENT PLAN

**ECONOMY, PLANNING AND
EMPLOYABILITY SERVICES**

APPROVED OCTOBER 2017

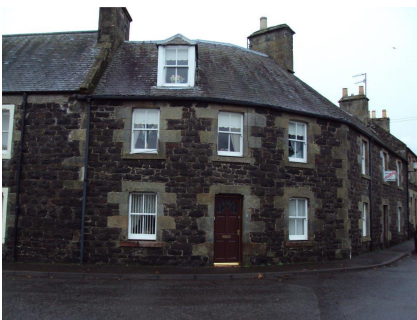
19th century contrasting dark whin stone with blonde sandstone margins and grey slate roof.

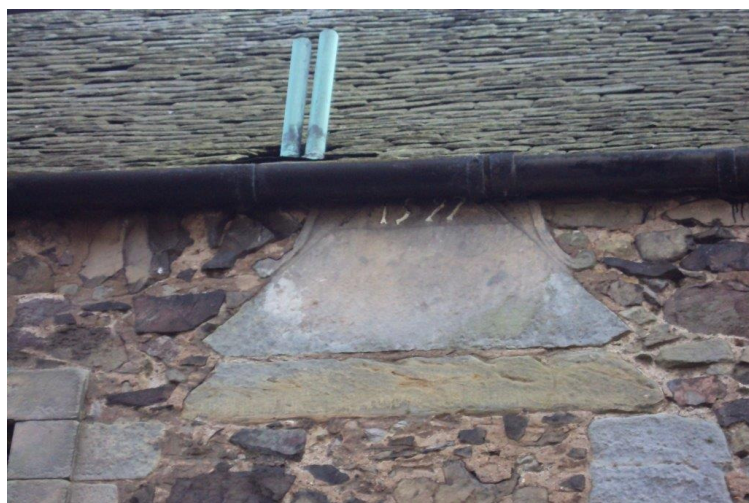
Scottish slate on Macduff House. Whin rubble masonry, probably missing an original harl.

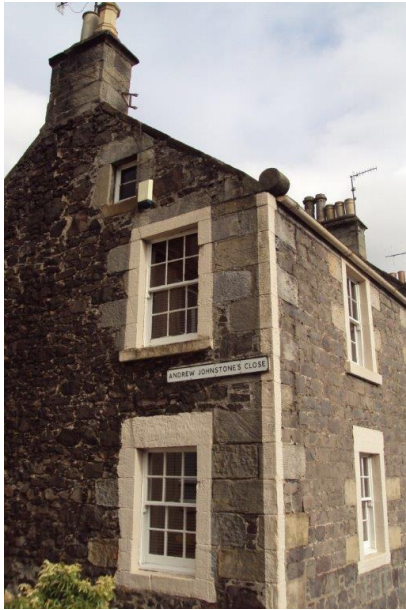
Particularly rich vernacular detailing including a scrolled skewputt at 39 Burnside.

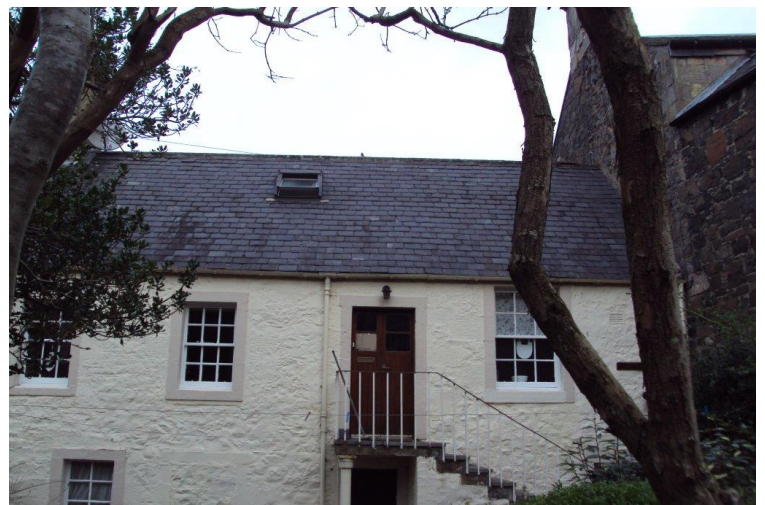
Late 18th century Orchard Cottage, High Street with railed and cast-iron pillared forestair.

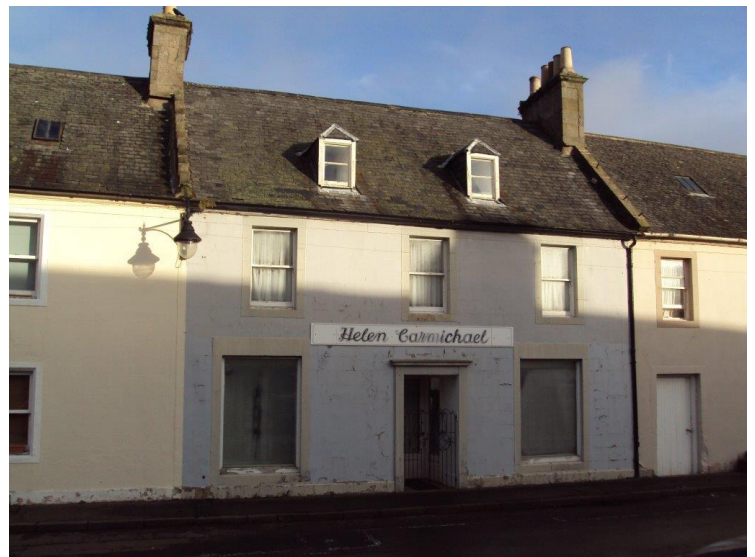
18th century simple style shop front with enlarged windows and minimal signage.

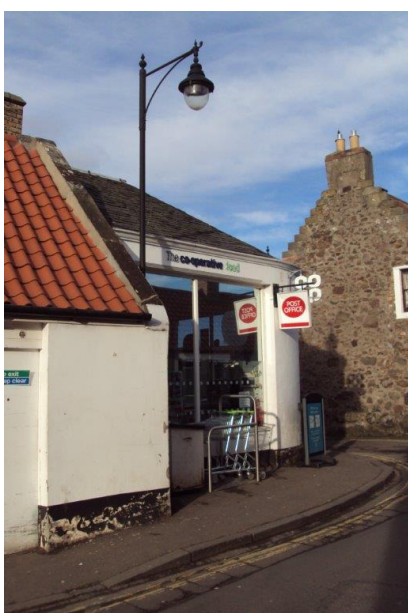
Inappropriate 'period' lighting column and luminaire.

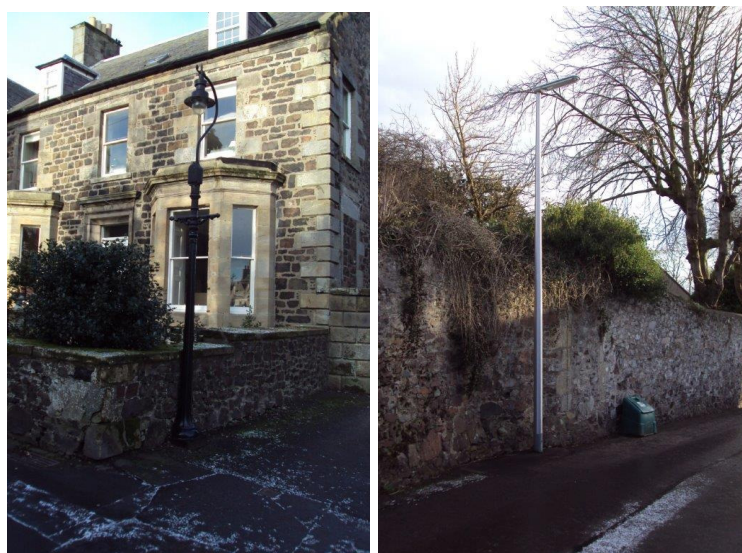
Contrasting original lamp post (above left) with a later swan neck addition on conversion to electricity, and (above right) an appropriate new lighting column and lantern.

It is likely therefore that the principal streets such as the High Street had lighting from the mid-19th century. Lighting would not have extended much further. A few of the original lamp posts survive with their gas lanterns replaced with electric ones. These are important reminders and should be retained in-situ if possible. However, as a guiding principle, the selection of any new 'period' versions off-the-peg should be avoided and instead any replacements should be based on archival evidence and historical research. If no documentation or historic precedent exists, the next best option is to procure high quality

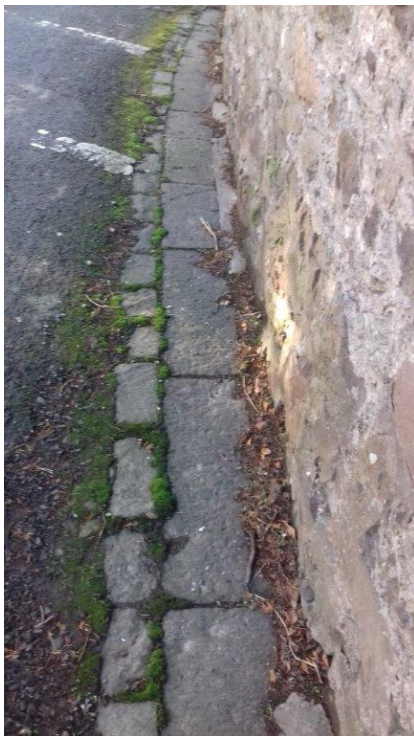
Surviving physical evidence for historic road surfacing and gutter detailing.

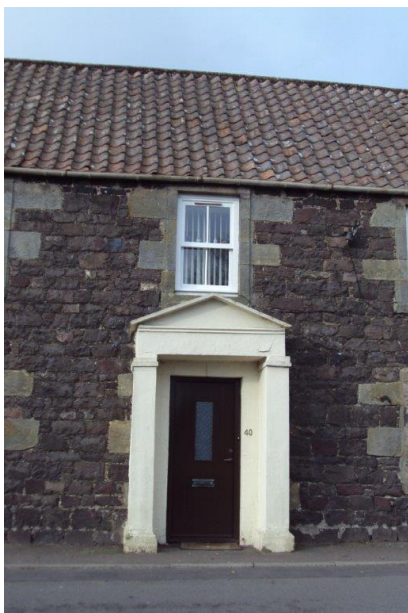
An example of the cumulative negative impact of the accumulation of historically inappropriate detailing: trickle vent; wide applied astragal and frame; glazed panel; letter box; door colour.

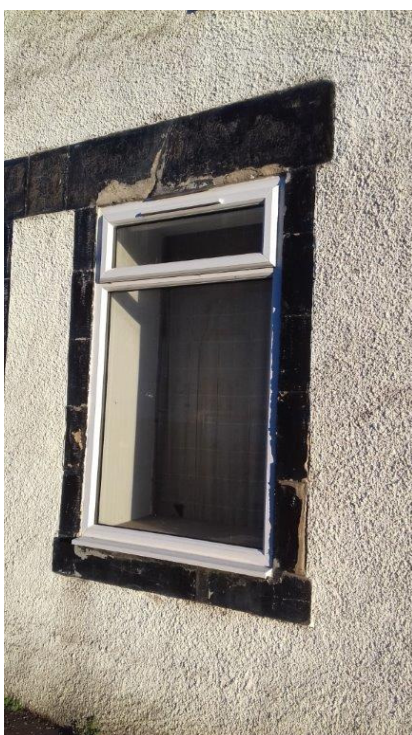
Examples (above and right) of some of the many inappropriate replacement windows and doors in the conservation area.

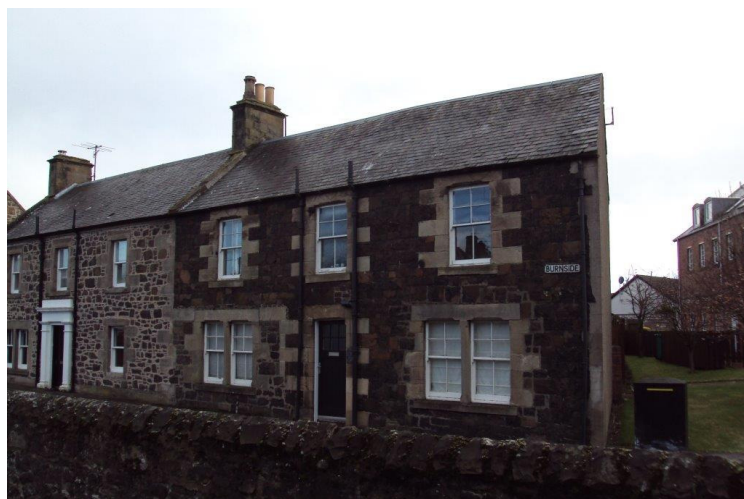
Example above left of the dramatic impact of inappropriate re-pointing.

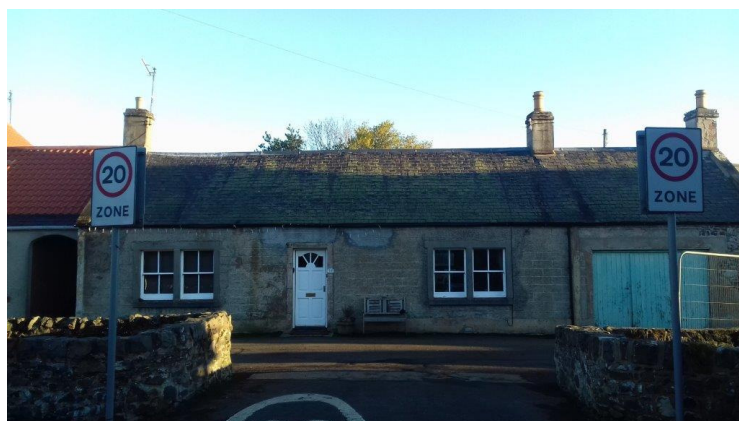
The above example (Upper Greens) shows the inappropriate use of modern Portland cement to patch repair 19th century stucco. The list description notes that it was also painted. Also note the inappropriate modern design and material (PVCu) of the front door.

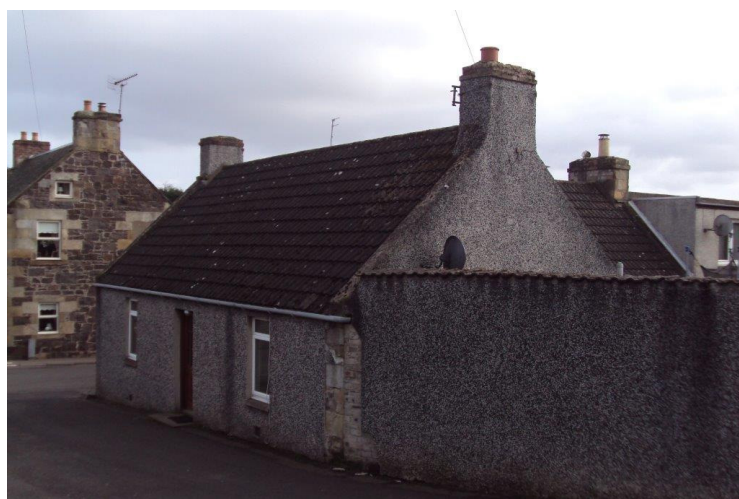
All the key character elements of the above cottage, on a prominent corner site, have been lost, although the core historic building remains. Note: concrete roof tiles; cement dry-dash render; PVCu casement

windows; satellite dish; plastic rainwater goods; loss of chimney cans; modern glazed and varnished door. The modern cement dry-dash render to building and boundary wall has typically failed, revealing the original masonry.

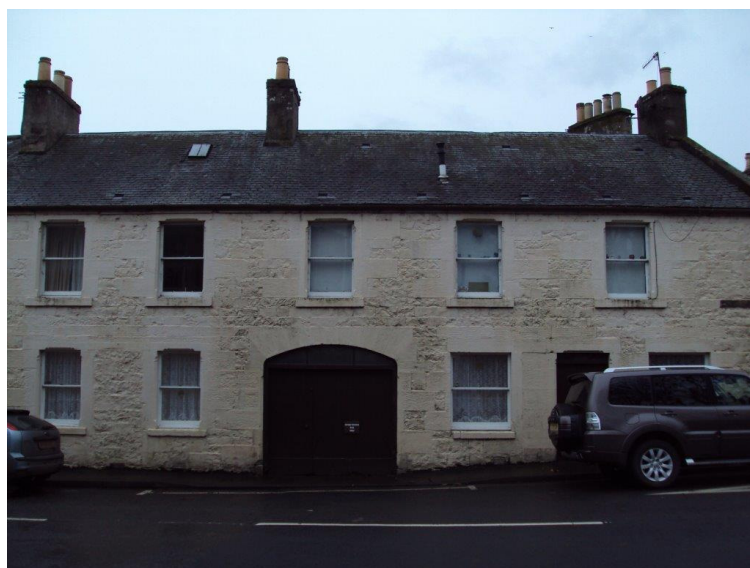
Inappropriate painted whin rubble masonry.

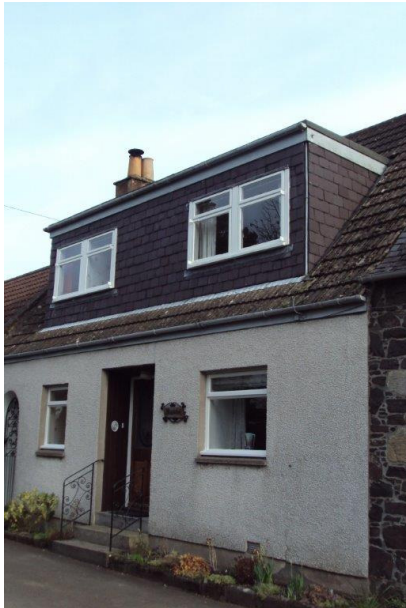
Examples above, below and right include: concrete roof tiles; roof windows; cement render; cement pointing; box dormers; modern style iron railings and gate; UPVc modern style windows and doors; plastic rainwater goods; cables; hanging baskets; trellis; carriage lamp; name sign; security camera/lighting; T.V aerials; vent pipes; meter box; modern plant varieties.

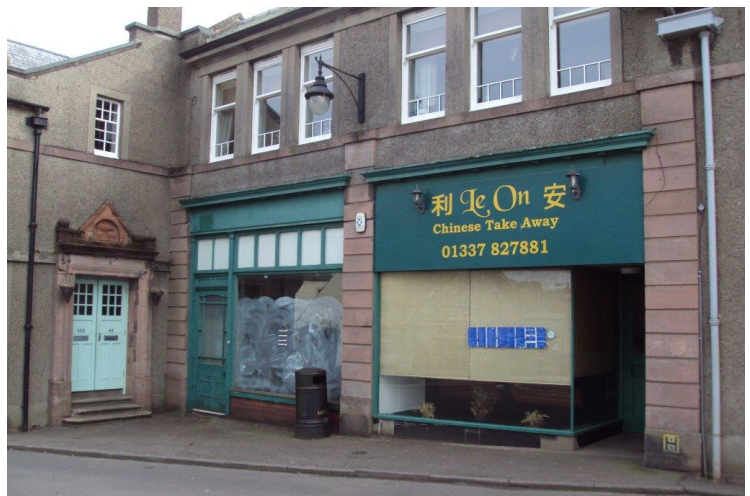
A pair of shop fronts (left original). The right-hand one with an over deep fascia board and carriage lamps added.

The above examples illustrate how easily the special architectural and historic character and appearance of a traditional shop front can be destroyed by inappropriate alterations. Detailed guidance on appropriate shop front design can be found in the Fife Council publication *Shop Front Design Guidelines* available online on www.fifedirect.org.uk.

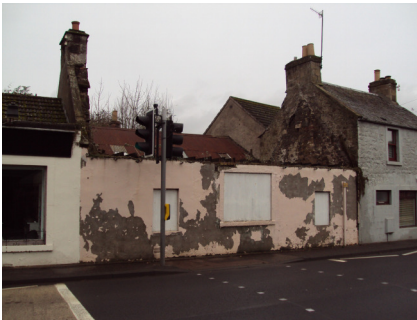
37 Cupar Road (above). Roof recently removed due to its dangerous condition.
