PITTENWEEM CONSERVATION AREA APPRAISAL and

CONSERVATION AREA MANAGEMENT PLAN

APPROVED AUG 2013

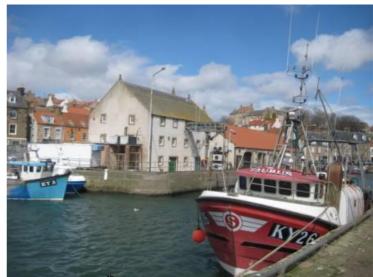
The former late 18" century granary (left) and new fish market (right).

The Granary building at the harbour was built in the late 18th or early 19th century. In 1861 the Parochial Directory lists exports of potatoes and grain and imports of salt for fish curing, wood and

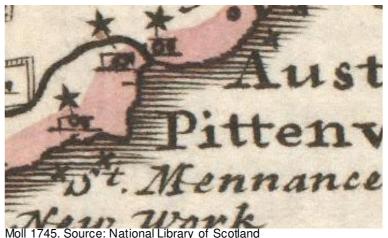
Until 1794 a timber wagon way linked the St Philip's coal mines and saltpans with Pittenweem harbour. This timber railed horse-drawn wagon-waylinked the coal-mines and saltpans at St Philips to the west, with the port at Pittenweem. A combination of the contours of the land and the obstructive tactics of Sir Robert Anstruther who owned intervening land in the town, dictated the route. This route is remembered in the so named 'Waggon Road'. It approached from the north down what is now New Grange Crescent, formerly known as Rope Walk (the long straight stretch of track being used, after it was abandoned, for making ropes - possibly using the flax grown extensively in Fife for the important linen industry). It then continued, avoiding various plots owned by Sir Robert Anstruther, to skirt the Priory immediately to the NE, before emerging between numbers 5 and 7 East Shore at the Coal Pier built by Sir John Anstruther in 1771 (demolished early in the 20th century).

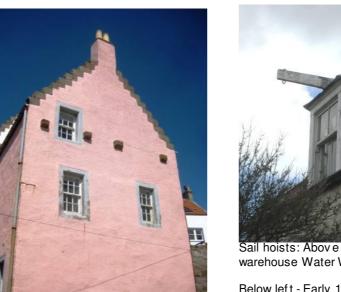
Characteristic crow-stepped gables.

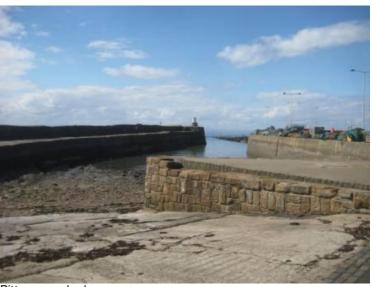
Pittenweem harbour

The harbour has been extensively repaired in modern times with inappropriate concrete and cement which has reduced its significance. However, it has examples of various periods of

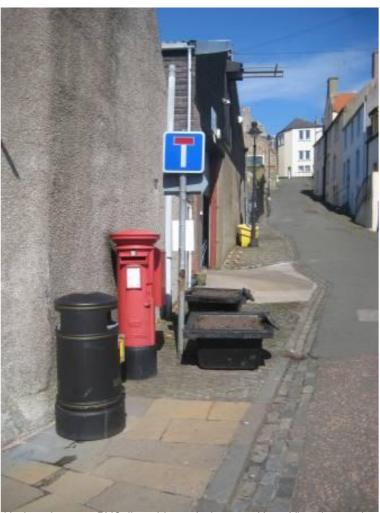
'Heritage' range PVC litter bin and planters. Note Victorian style street lights in background and the traditional pillar post box.

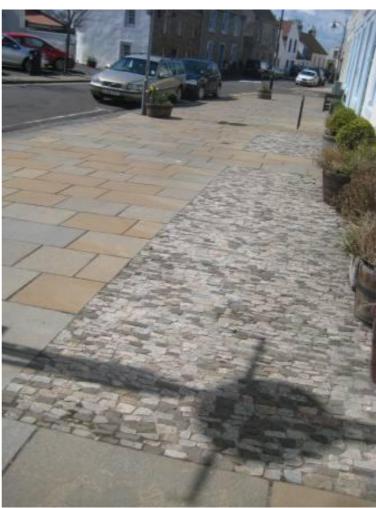
Hardscaped area on the High Street resurf aced using a mixture of paving and sudo setts/horonizing using non-indigenous stone types.

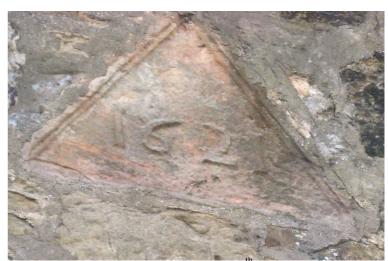
1621 date stone set in gable wall of early 19th century house 27 James Street.

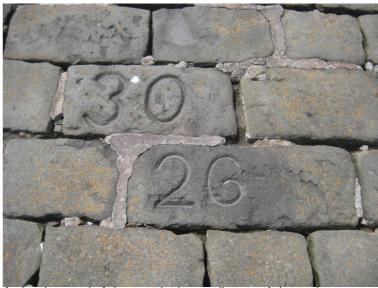
At the shore end of the outer harbour wall some of the paving stones have numbers engraved in them.

The first fishing boat to return with its catch placed

its haul alongside stone number one, the second boat at stone two and so on. When the market opened, the fish was sold in strict order of landing. This traditional feature is in danger of disappearing when sets are lifted and re-laid or even lost when maintenance and repairs works are undertaken.

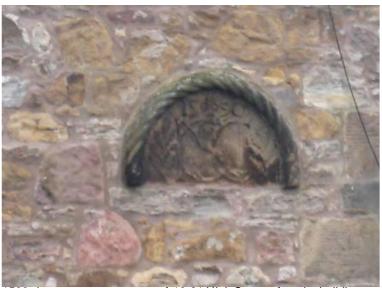
1590 date stone now on rear of 19-21 High Street after the building was re-fronted early in 19th century.

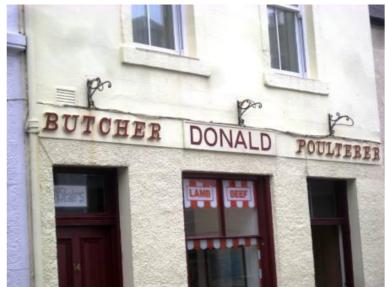
Examples in the High Street of appropriate signage lettering styles.

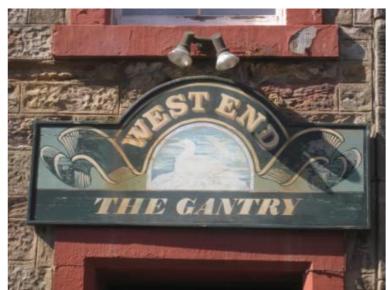
Examples above and left from the conservation area of traditional hand-painted sign writing.

Within the conservation area shop front fascias and signage are generally appropriate for the individual buildings and the area and follow the principles set out in the guidelines. In particular fascia boards are limited to small ones, often positioned over the shop

door. Elsewhere lettering is applied directly to the original enlarged masonry band course or as individually cut and fixed letters or painted directly onto the stone. Colours and lettering should be traditional and text content restricted to usually just a name and the type of business.

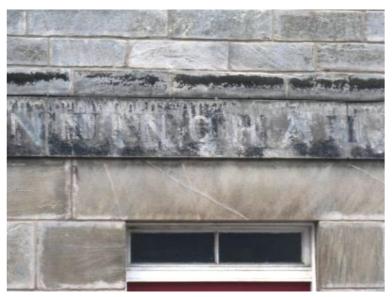
A rare surviving example of hand painted traditional sign writing at 46/48 High Street. And below a more recent example from South Loan.

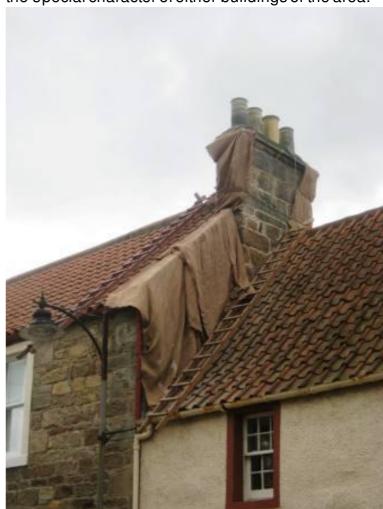
As in the above example of the use of traditional lime mortars, these should be used in preference to modern cement rich mortars which are both technically and visually inappropriate.

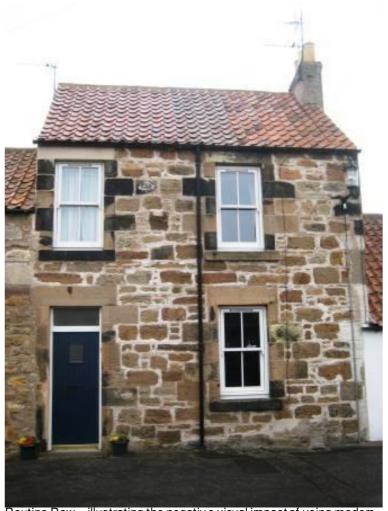
Routine Row – illustrating the negative visual impact of using modem ordinary Portland cement for re-pointing a traditional rubble masonry wall. Note also the trickle vents for the double glazed windows.

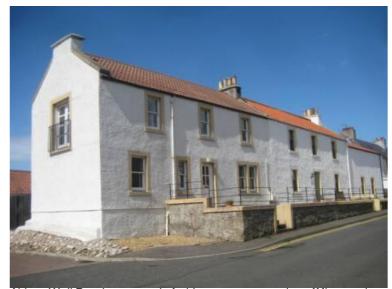
Abbey Wall Road – removal of chimney cans, capping offflue, and introduction of a balcony style gable wall window; half glazed front doors and use of brilliant white modern masonry paints gives this renov ation the character of a modern dev elopment.

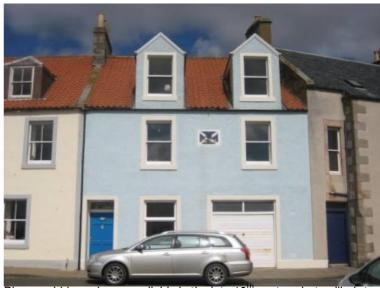
Blue would have been available in the late 19th century but unlikely to have been used on this listed building on Mid Shore.

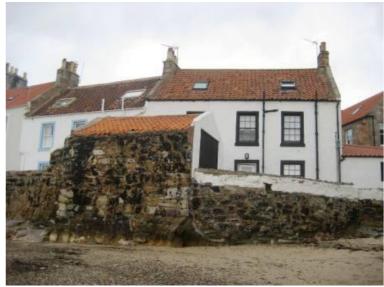
Pitch black masonry walls now painted in brilliant white modern masonry paints.

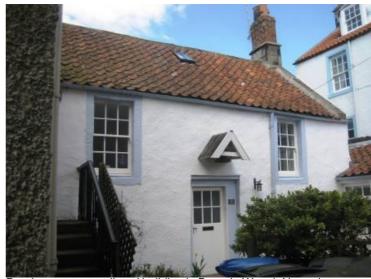
Porch canopy on a listed building in Bruce's Wynd. Note also inappropriate half glazed door and coach lamp.

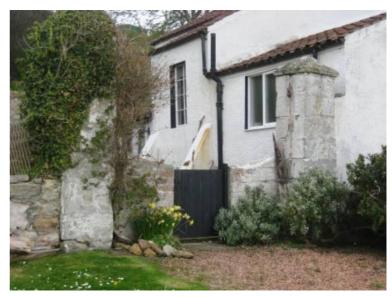
Unlisted entrance gate piers and wall and former gas works buildings. Shown on OS 6" map of 1853 at 21 West Shore located on western edge within the conserv ation area.

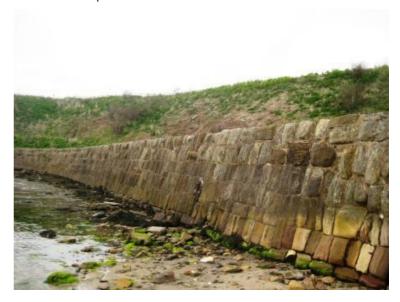
Below - associated unlisted sea wall and wharf adjacent to former gas works outside the conservation area at West Shore, shown on 1853 OS 6" map.

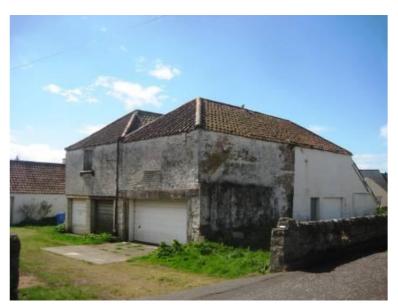
Unlisted Boyters/Council Store St Adrian's Road. Buildings are shown on this site on maps from mid-19th century onwards including a fish curing premises and sawmill.

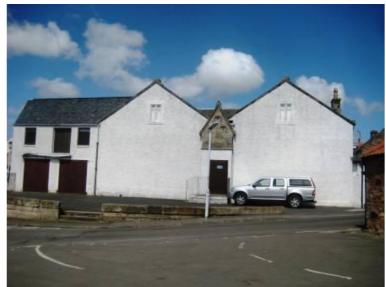
Unlisted Scout Hall on Backgate. Formerly a 'shambles' a slaughter house; the South School in 1852 and a Picture House in 1920s. Shown on OS 6" map of 1853.
