**CELLARDYKE CONSERVATION AREA APPRAISAL
and
MANAGEMENT PLAN**

**ECONOMY, PLANNING AND
EMPLOYABILITY SERVICES**

APPROVED JUNE 2015

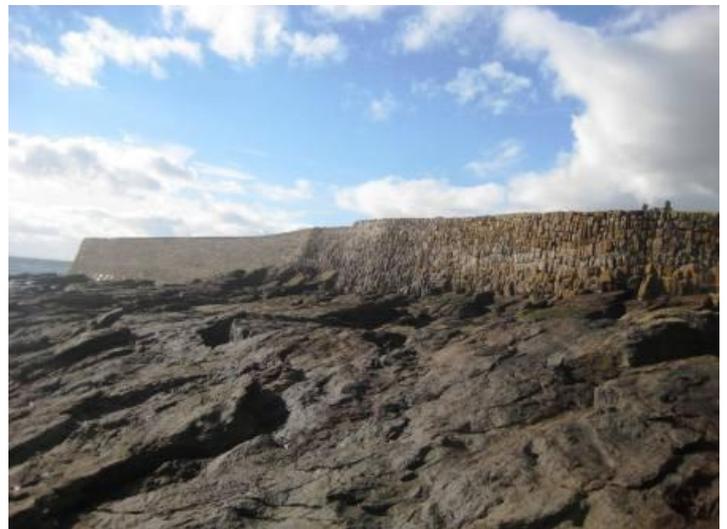
The main outer pier of Cellardyke's harbour, Skinfast Haven

Skinfast Haven, Cellardyke's category B listed harbour has developed in stages with corresponding distinct styles of construction. It is vital to understand the technology of each to ensure that different parts are maintained and repaired correctly. For example, the oldest, inner section of the main outer pier has an open jointed masonry with timber wedges to keep it so. Sections of masonry have, however, been pointed in modern cement. Elsewhere an inappropriate style of pointing with liberal use of pinning stones has been

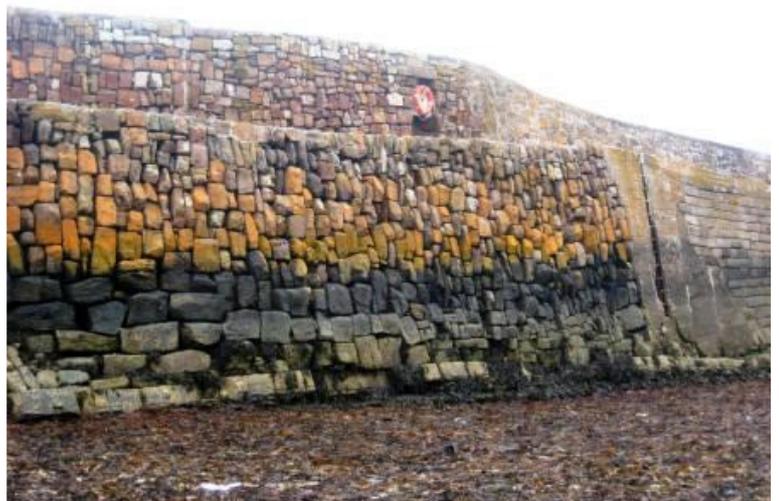
The outer pier showing the rebuilt part to the right.

The harbour improvements in 1829 extended the outer pier and built out a short pier from the bulwark. This short pier was removed by 1854 and the present stone pier built. The great storm of 1898

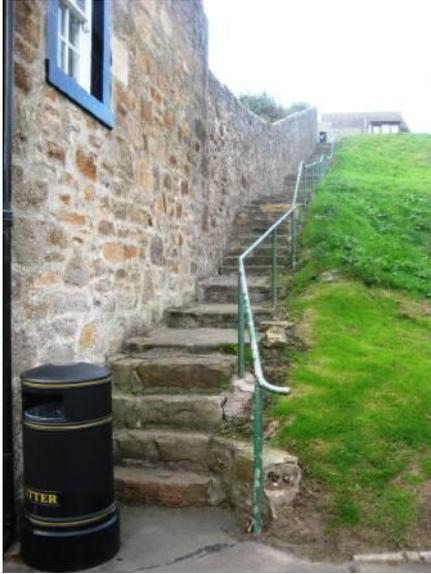
Steps at the NE edge of the conservation area at the Braes show well the steep gradient.

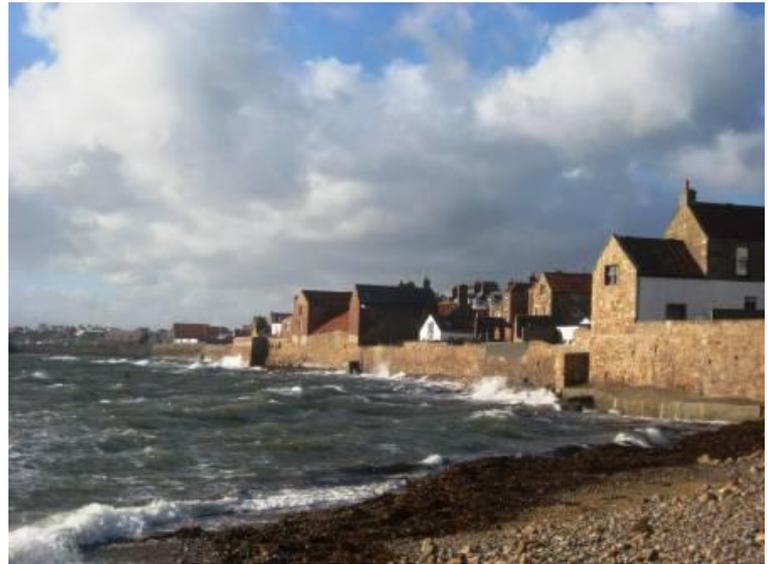
Sea walls protecting the made up land at the SW end of the conservation area.

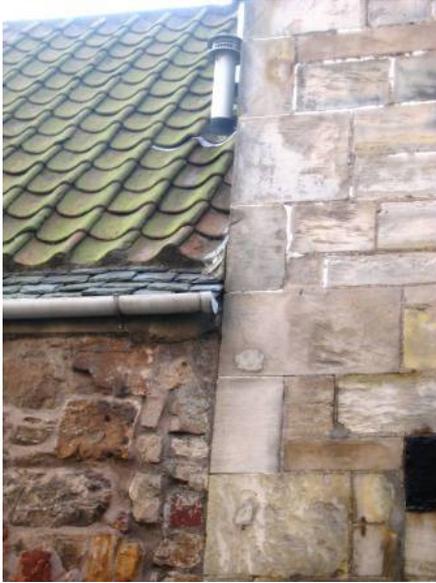
Rough rubble masonry left contrasting with snecked squared rubble right with its mixture of risers, levellers and snecks. Note characteristic traditional pantile roof with a slate easing course.

A few later buildings, mainly non-domestic, post the arrival of the railway to Anstruther, are constructed in red brick masonry. On some front elevations sandstone masonry units may be squared and of similar dimensions, on most it is much more irregular. Most early buildings are constructed in poor quality local sandstone rubble. There is some surviving slaister or harl pointing where the flush pointing extends over the face of most of the stone units leaving only the largest bare. It is likely that this style of finish was common on these poorer quality sandstone rubble buildings.

There is evidence of a continuing vernacular tradition of finishing these snecked mortar joints with horizontal scratched imitation joints. Some later mid-19th century buildings adopted the then fashionable snecked style of masonry using better quality imported sandstone and there are some good examples.

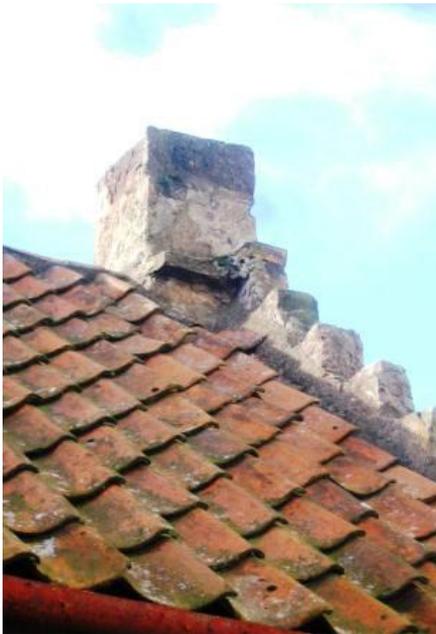
Examples of traditional red pantile roof, stepped-gable and thackstone.

The majority of buildings are built in the characteristic 'East Neuk vernacular' style, with pantiled roofs and raised gable skews, over a third with corbie or 'crow-step' gables. This style was highly influenced by the architecture and building practices of the Low Countries through strong trading and cultural links from the earliest medieval times.

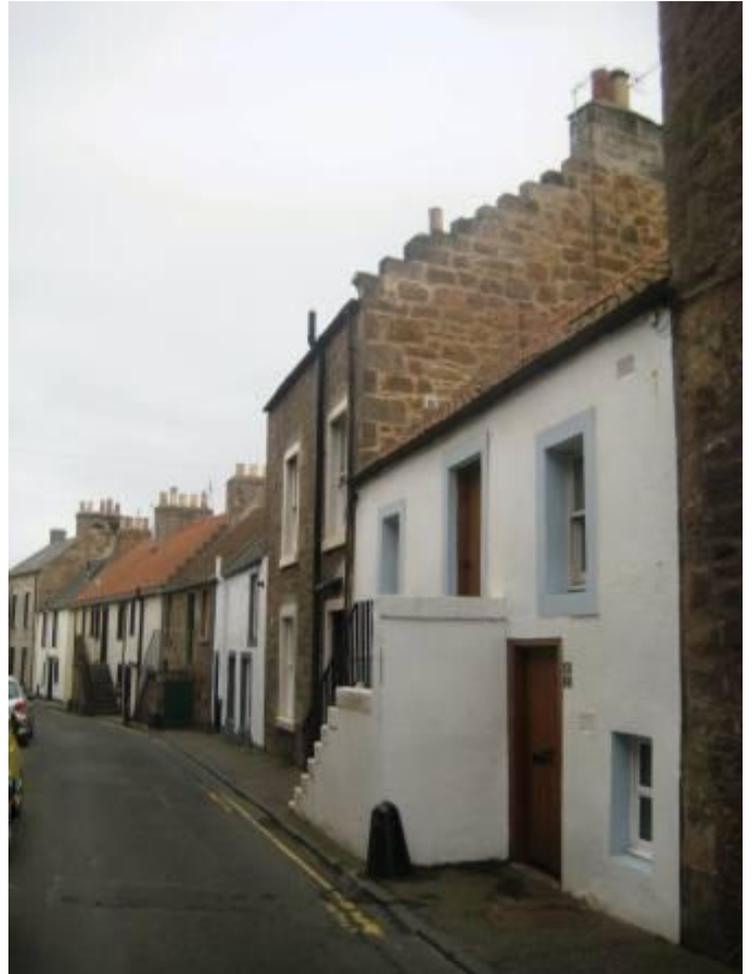
Examples of traditional fore stairs (John Street).

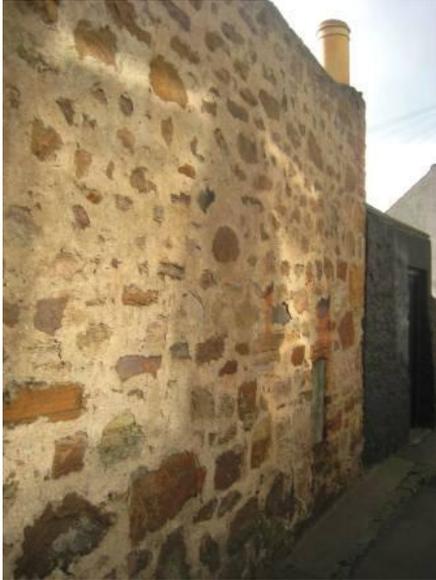
Example from the conservation area of traditional 'slaister' or 'harl pointing'.

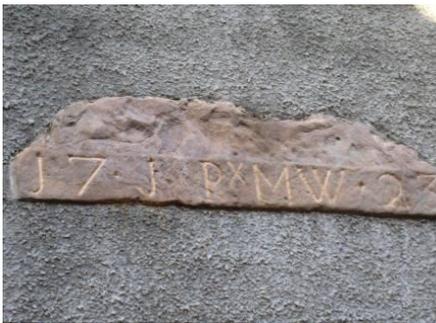
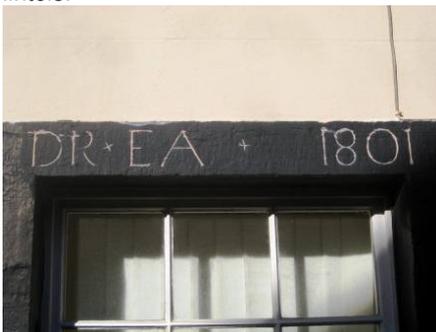
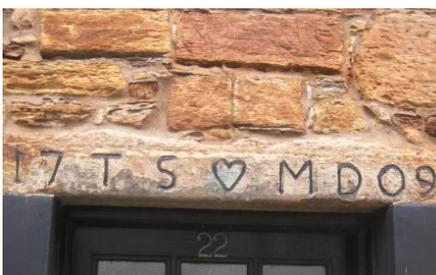
Examples from the conservation area (above and below) of dated marriage lintels.

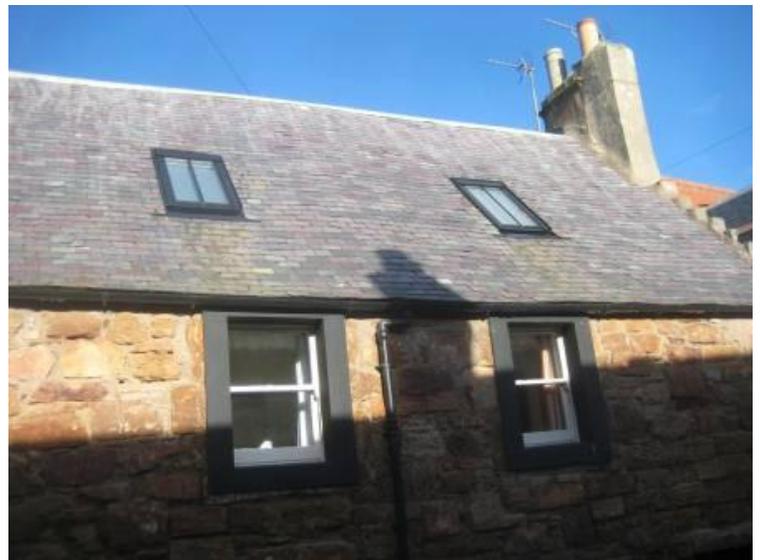
Welsh Bangor heather coloured slate roof.

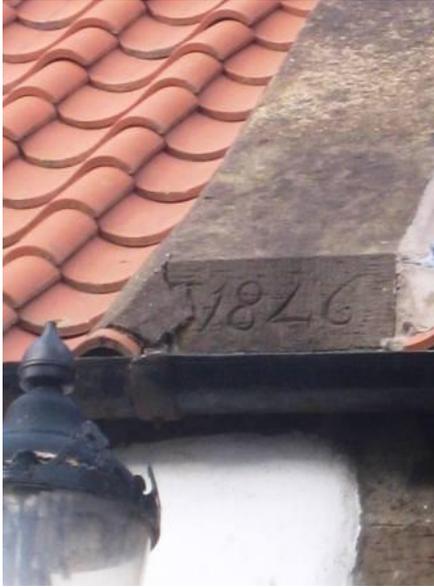
A rare dated skew-put (James Street).

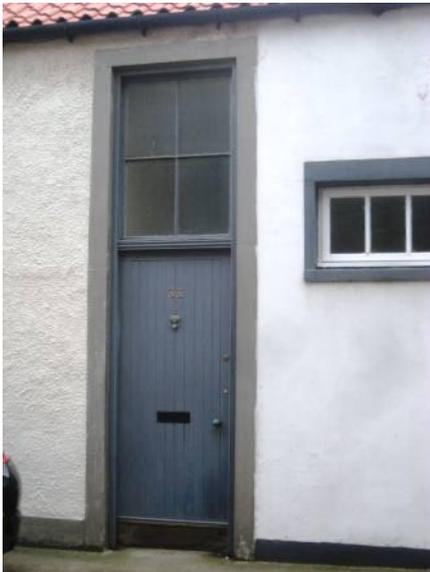
Massive transom light in place of a forestair door.

Most roofs have managed to avoid the addition of roof-lights or dormer windows. In the late 19th century when fishing gear became bulkier many lofts were utilised and dormer windows with hoists installed. Many still have the dormers but few of these hoist gantries survive. Such lofts continued into modern times, being included for example in the design of the social housing just outside the conservation area on Toll Road. Another unusual local feature is the large transom light over the front door which extends to the roof eaves. This feature, found on a number of buildings, may be a solution to the obsolete door opening following the removal of an earlier fore stair.

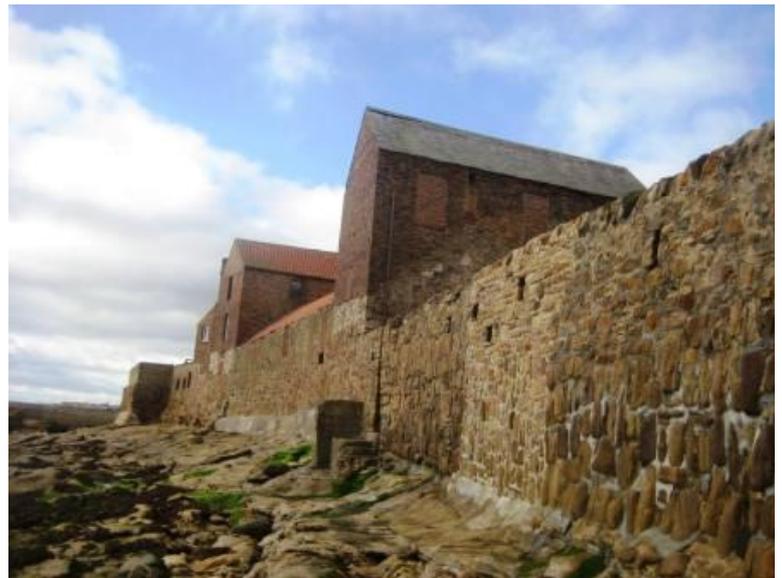
Oilskin factories off western end of James Street (one of four in Cellardyke in 1866) built using imported brick post arrival of railway in 1863.

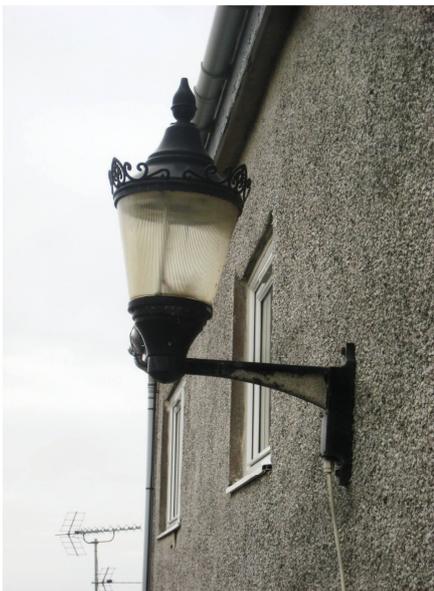
Above and below – modern 'period' street lamps.

Lighting and other street furniture can be an important component in enhancing the distinctiveness and character of a building or conservation area. Original cast iron columns for gas and electric lighting from the 19th century were often elegantly designed, with classical mouldings or other intricate details which complemented the contemporary local architecture. In the conservation area any original street lighting has long been replaced with the current more utilitarian steel columns of hollow circular section, some with modern lamps or others with ornate reproduction lamps. The different styles of reproduction 'period' lamps have no historic precedent and contribute little to the authentic character of the conservation area.

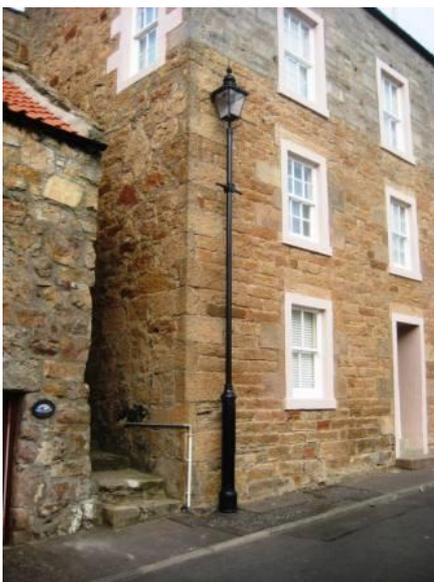
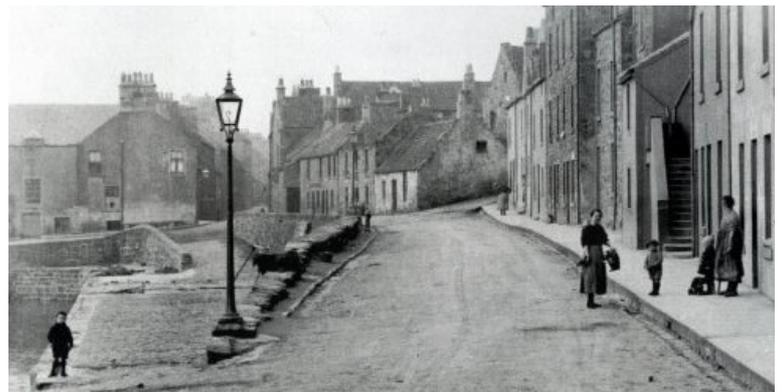
Above-late 19th century view of Shore Street. Note street light and public water hydrant. Contrast with view from a similar point. Note buildings in centre mid-ground now demolished. Source: CANMORE

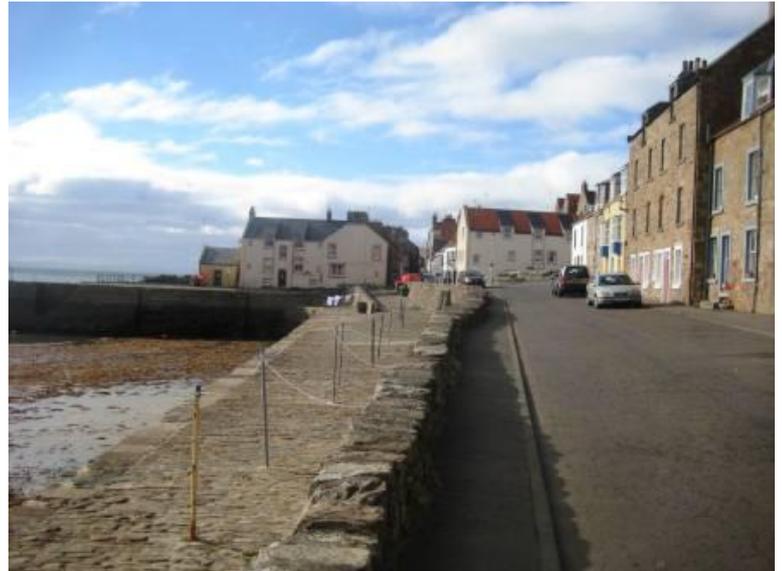
An example of an original street lamp post may have survived from the mid-19th century located at the western end of Braehead. Historic street lamp designs are evident in photographs from the late 19th century. There was a gas works nearby in Anstruther Easter.

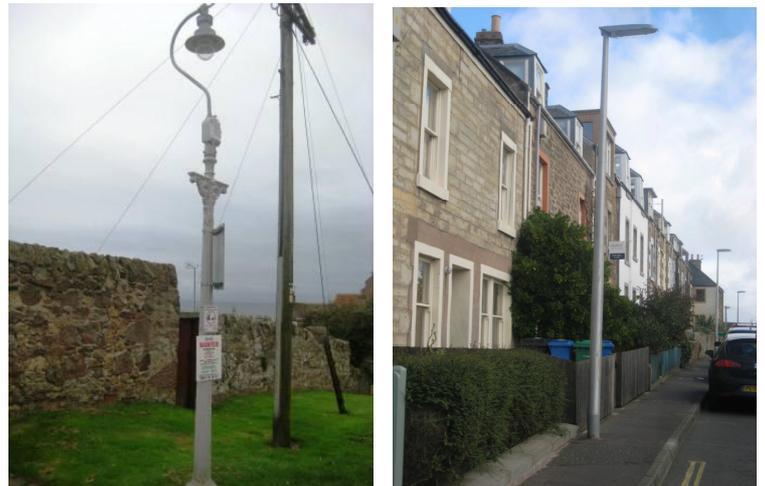
Left: Later lamp on an early, possibly gas, lamp column located at end of Braehead.

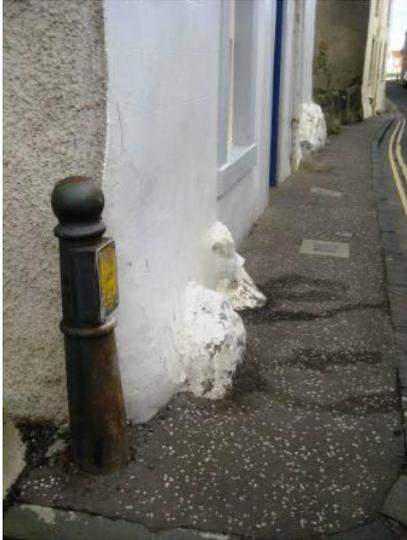
An example of the many cast-iron bollards protecting buildings along the main streets

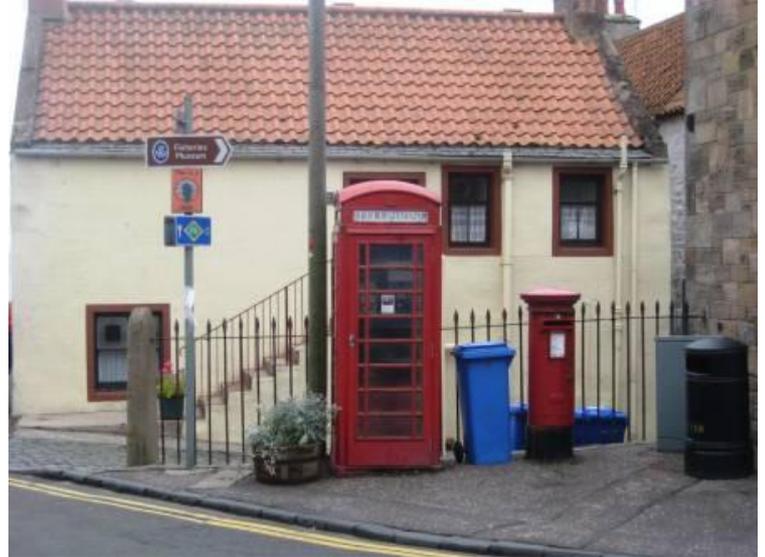
Accumulation of street furniture and other items at corner of Tollbooth Wynd and James Street, including just out of shot, a satellite dish. This is historically a highly significant part of the conservation area.

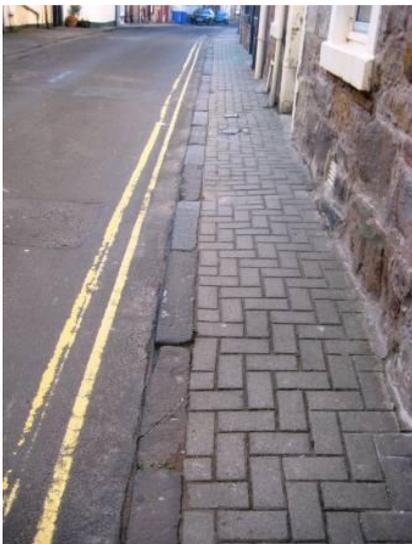
Modern concrete block paving above.

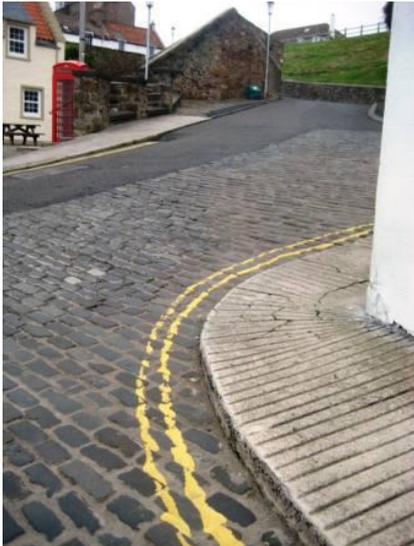
Mixture of old and new materials and methods.

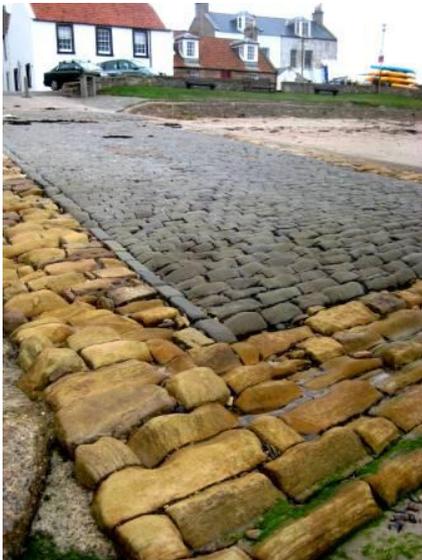
Harbour slipway constructed of whin sets with sandstone margin.

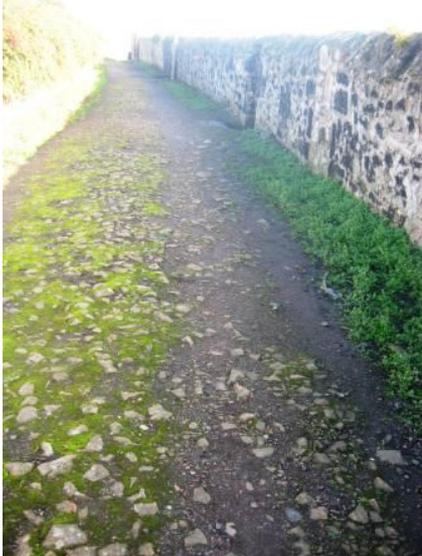
Traditional stone chipping and adjacent tar painted walls on Braehead.

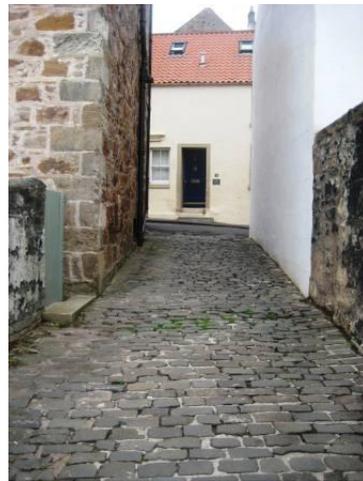
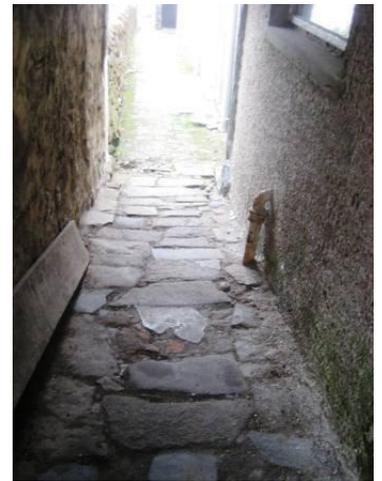
Left-traditional whin sets. Right-traditional rough stone slab paving.

Cobbles and compacted stone chippings using locally sourced sandstone or whinstone would provide a sympathetic historic setting for most buildings. For roadways the most historically sympathetic surfacing compatible with modern vehicular traffic would be hot-rolled asphalt with

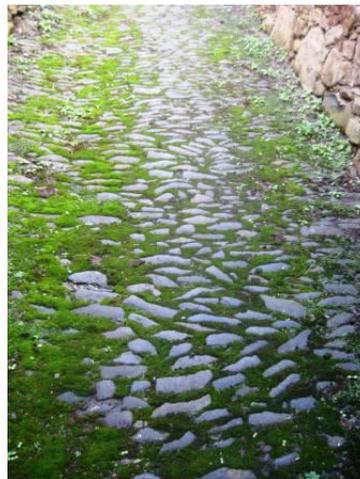
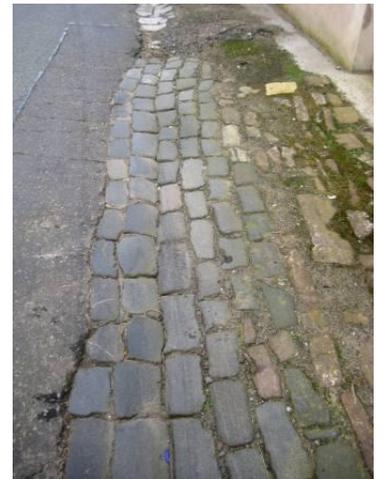
Left-whin horonising and cobbles. Right- traditional road gully detail.

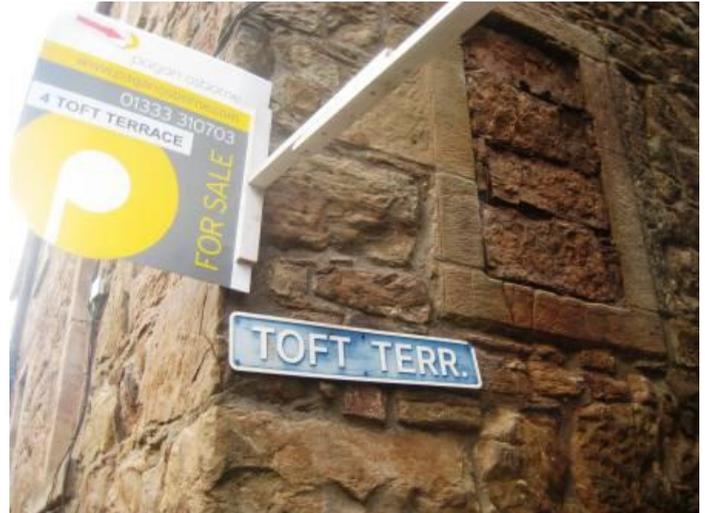
Typical street sign

There are unfortunately no surviving examples of historic street signs to restore or to act as templates for the manufacture of replacements. Any new signs should preferably be of a style different from the rest of the village, be of good quality, of an appropriate design to protect and enhance the special character and give the area a cohesive identity.

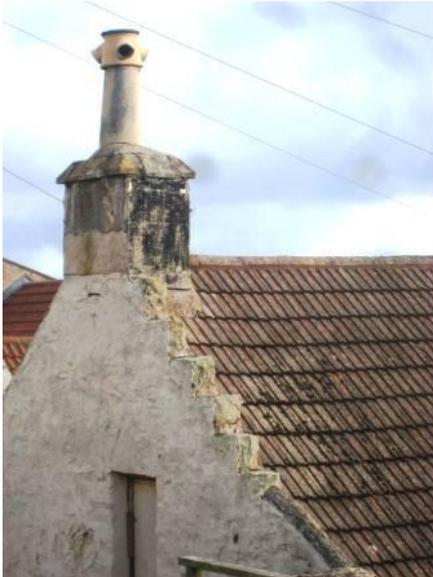
Modern cement roof tiles on an 18th century cottage.

The correct use of traditional materials and detailing is important in defining and enhancing the special character of the area. Roofs form a dominant character element in vernacular architecture and they are particularly visible within the conservation area due to the sloping topography. Where examples still exist they are particularly valuable in helping inform the choice of appropriate new materials or details. Materials or components have a limited life and many will have already been renewed. It may not simply be a case of replacing like for like or retaining things as they were at the date of statutory listing. Some buildings have been re-roofed for example with plain Rosemary clay tiles or modern concrete tiles.

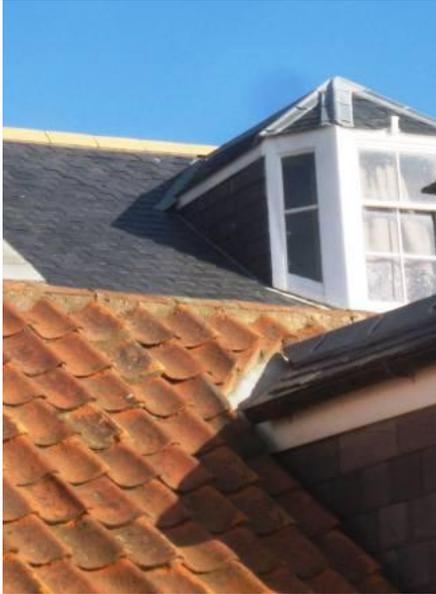
Above - synthetic fibre-cement roof slates used on a late 19th century category B listed building.

The particular mix and diversity of materials can be an important component of the character of an area. However, using similar types of slate or pantile particularly on a single terrace of houses or cottages even though they are in different ownership helps enhance their architectural and historic identity. Similarly, too great a variety of chimney can or ridge or skew treatments may have an adverse impact. 18th century or earlier buildings may use materials that were not available when built and whilst for example it is not practical to re-instate what would have been originally thatch in many cases, a more historically contemporary material may help enhance the significance.

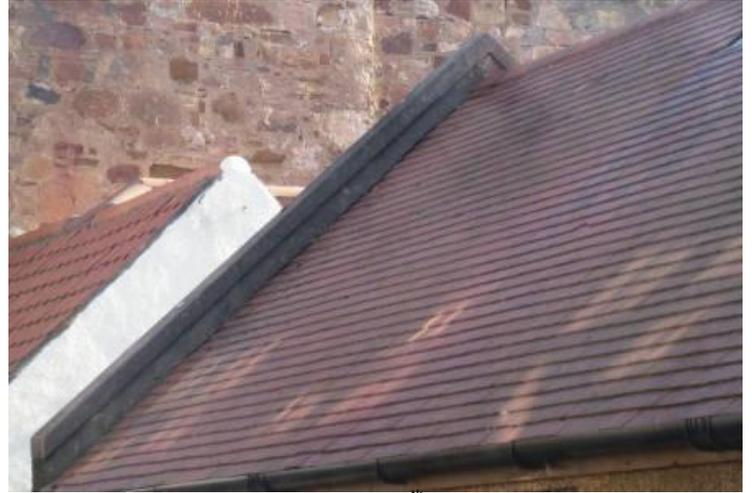
Rosemary plain clay roof tiles on a 19th century cottage.

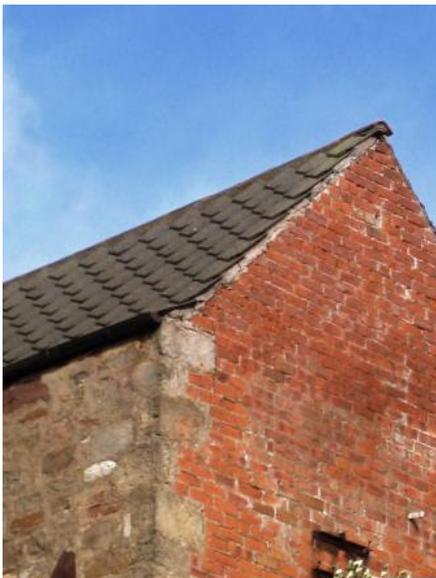
Category C listed 19th century store with brick rear gable wall. One roof slope has had the pantiles replaced since listing with modern grey concrete tiles.

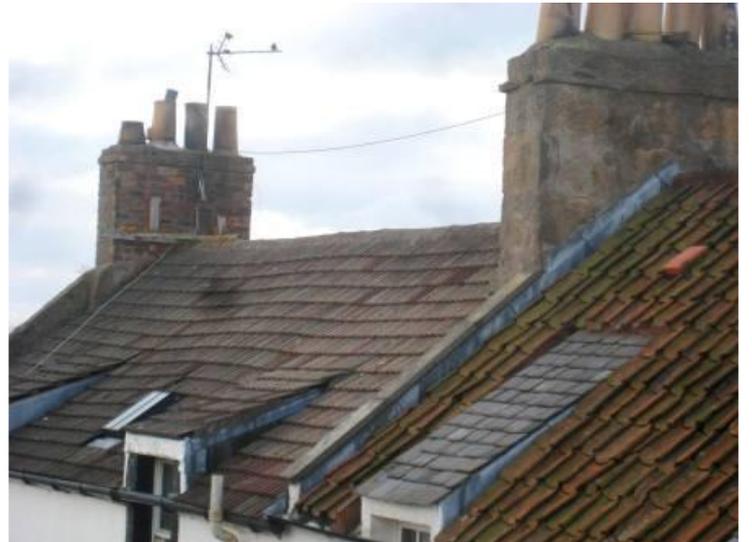
Contrasting appearances of traditional roof tiles to right with the modern versions to left.

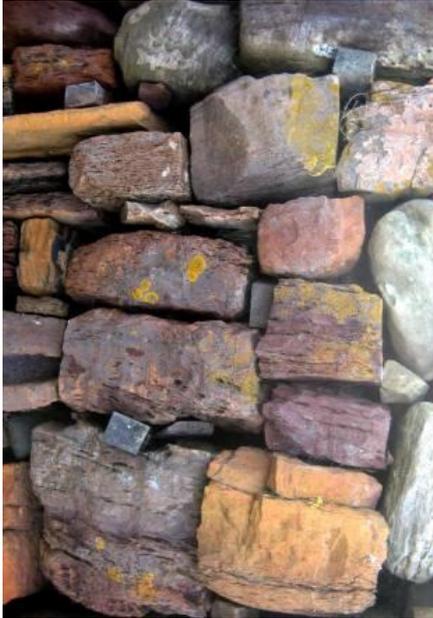
Contrasting methods of construction used on harbour piers. Above Outer Pier open vertical jointed wedged masonry (mid-15th century) and below West Pier early shuttered mass concrete (late 19th century).

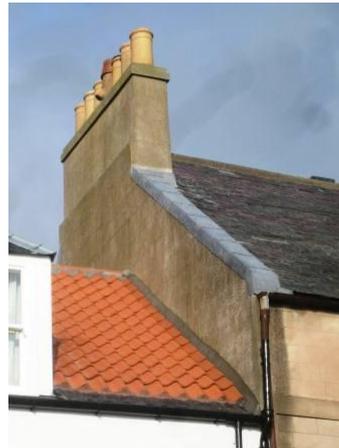
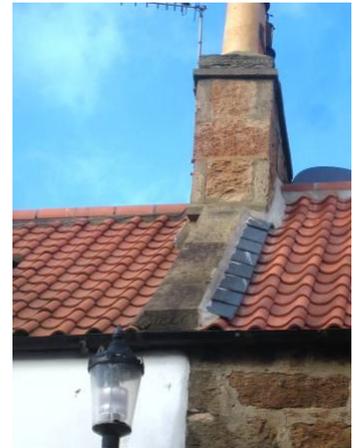
Examples of non-traditional skew cope detailing. Left-lead sheet encasing the gable skew cope. Right-row of slates over tile /skew junction.

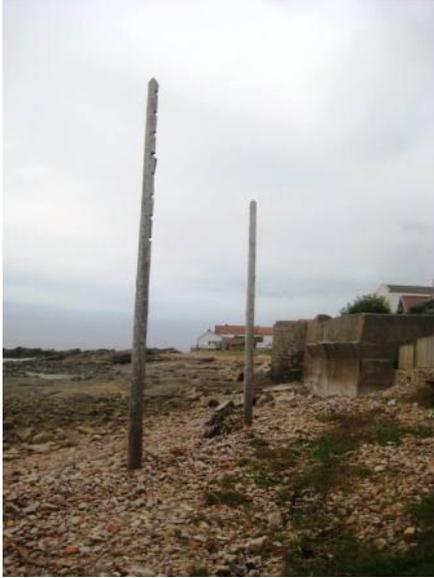
Former fishing net drying poles on the foreshore. Others survive in private gardens.

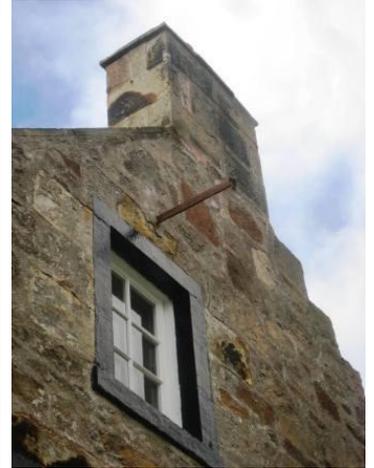
Above left -re-incorporated timber former fishing gear hoist gantry over a dormer window. Above right-unusual metal former fishing gear hoist gantry over a gable wall window.

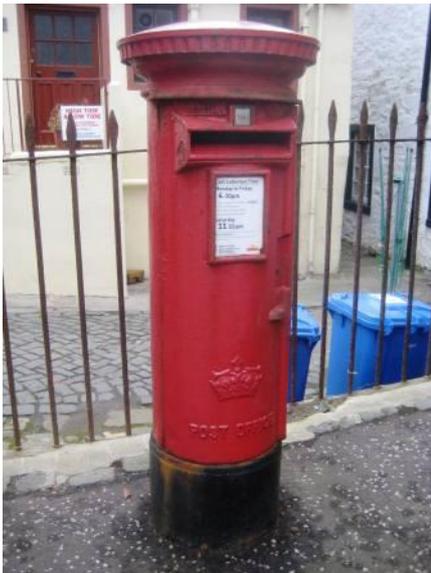
Traditional red pillar post box, cast at the Carron foundry Stirlingshire. Note post 1955 use of Crown of Scotland.

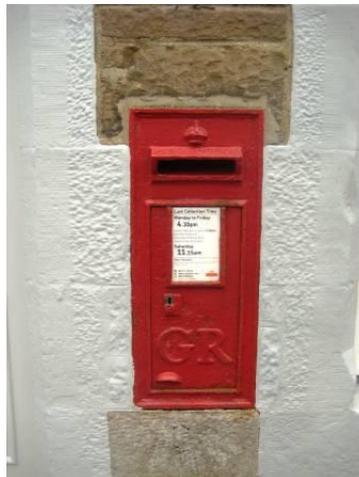
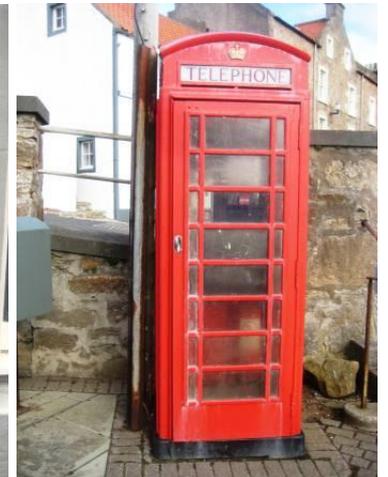
Above left - George V wall post box. Note Tudor Crown. Right –one of two classic K6 Jubilee telephone kiosks, this one at the harbour and far left a classic pillar box cast in the Carron Foundry.

The once ubiquitous traditional red telephone call box is in most places now redundant and its survival as a traditional element of the historic streetscape at risk. There are fortunately still two examples of the classic K6 Jubilee version in the conservation area. Made in the Saracen and Carron Foundries in Glasgow and Falkirk respectively, the example on James Street with its Tudor Crown appears to pre-date the introduction of the Crown of Scotland in

1955 as on the one in Shore Street. Both remain in use and are therefore maintained, as are fortunately the George V wall post box and a pillar post box, which should help ensure, though not guarantee, their survival.

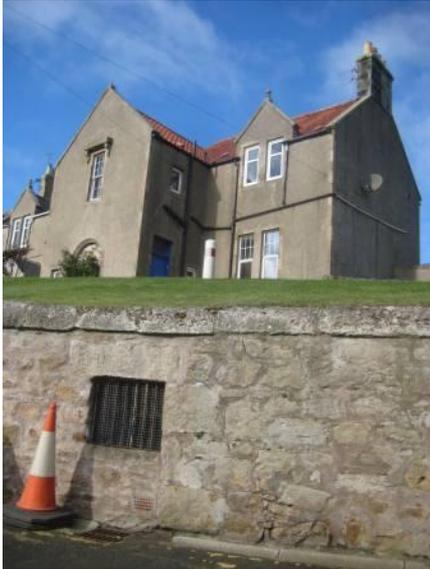
There is little evidence now of the many wells shown on the first Ordnance Survey map. Most drinking water before the introduction of mains water was drawn from these wells. The surviving one in Urquhart Wynd (also known as “Screw Wynd”) is therefore significant. These in turn were replaced by public water hydrants though none survive.

Former public well at top of Urquhart Wynd

Other outbuildings such as wash houses may similarly become redundant, neglected and if no alternative use found eventually demolished or removed. Wells and public water hydrants were once a familiar part of the street scene. The well at the top of Urquhart Street is a rare surviving reminder.

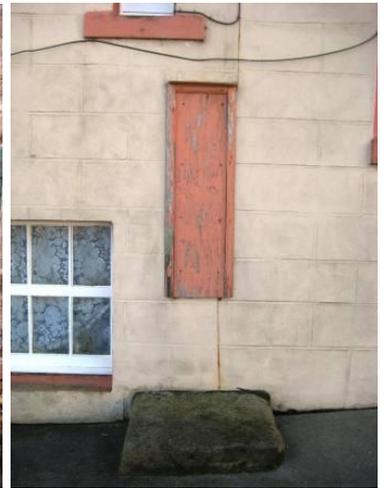
At Cellardyke's harbour the public barometer, which may have dated from the mid-19th century, has unfortunately disappeared and only the housing and plinth remains as a reminder. In 1857 the Board of Trade gave Rear Admiral FitzRoy permission to issue public barometers to the most exposed and least affluent fishing villages in Great Britain and Ireland to warn of approaching storms. Before this, in 1850, David Milne Home had issued Aberdeen, Peterhead and a number of other places in Scotland with public barometers.

Left-rare surviving example of an original fisherman's gear store door
Right-location of former public barometer at harbour

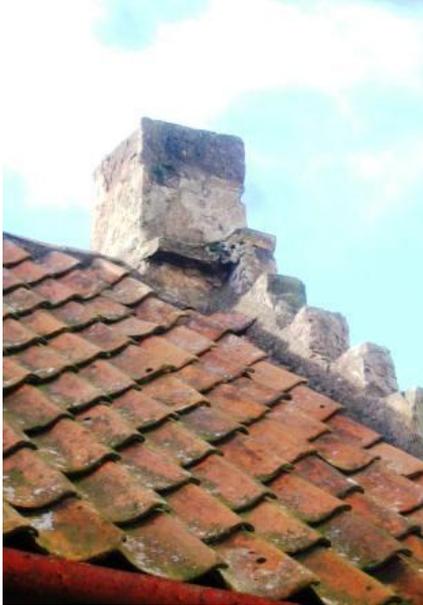
Example of a thackstane detail at base of chimney head

Within the conservation area many chimney heads still have thackstones, usually an indicator that they would once have been thatched. This is an important detail which is often lost when chimney heads are re-built or removed.

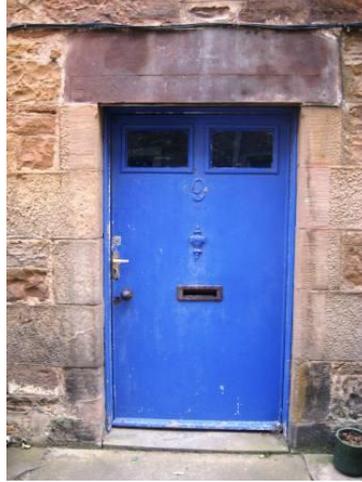
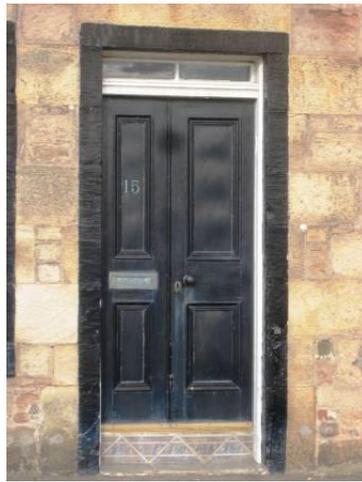
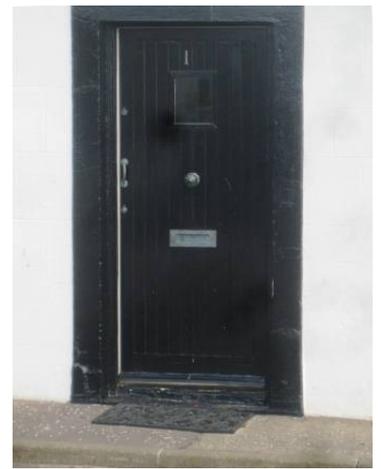
Surviving examples, as above, of early or original door styles are valuable for informing the choice of historically appropriate replacement doors on similar buildings.

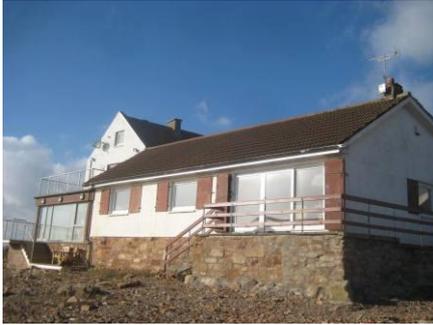
Contrasting original traditional stepped gable to left with modern version to right. Below same building viewed from the foreshore.

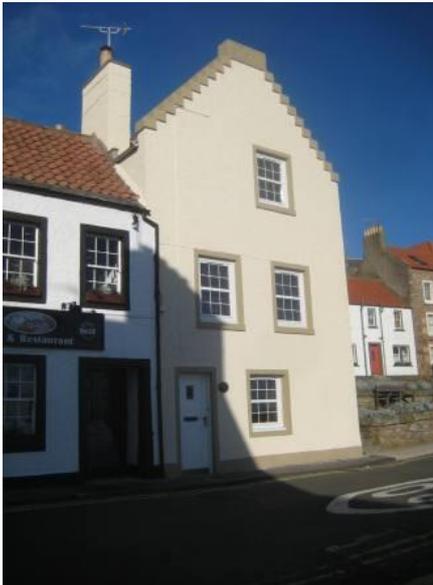
Above and below- a new building which incorrectly uses 'traditional' features and modern materials including PVCu windows and door.

New interventions in historic settings do not need to look 'old' in order to create a harmonious relationship with their surroundings. It is usually best not to try to replicate traditional vernacular features or introduce new ones which risk ending up as pastiche. The orientation, building line and density, proportion of garden ground, treatment of boundaries, building scale and mass, fenestration patterns, colours, materials and architectural paradigms used should be sympathetic and reflect the character of the place even if the building is clearly new.

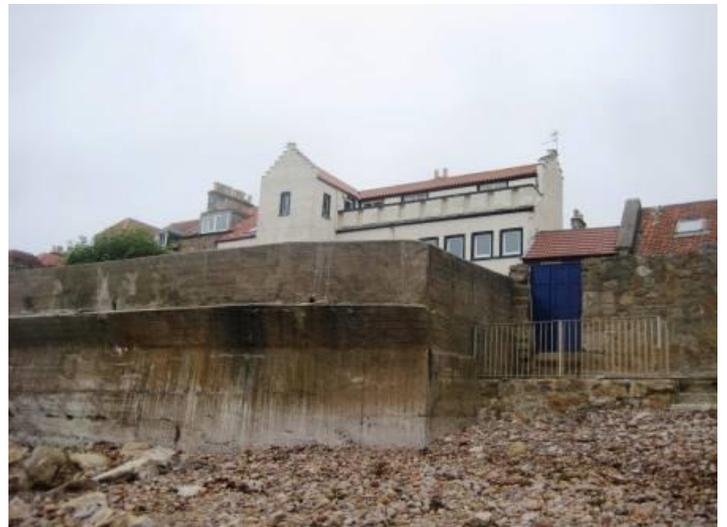
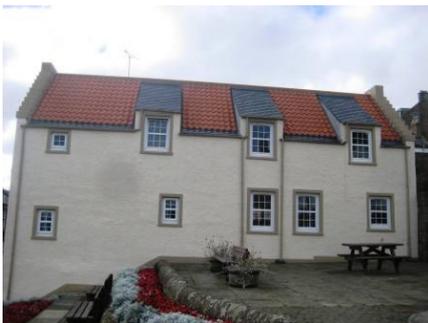
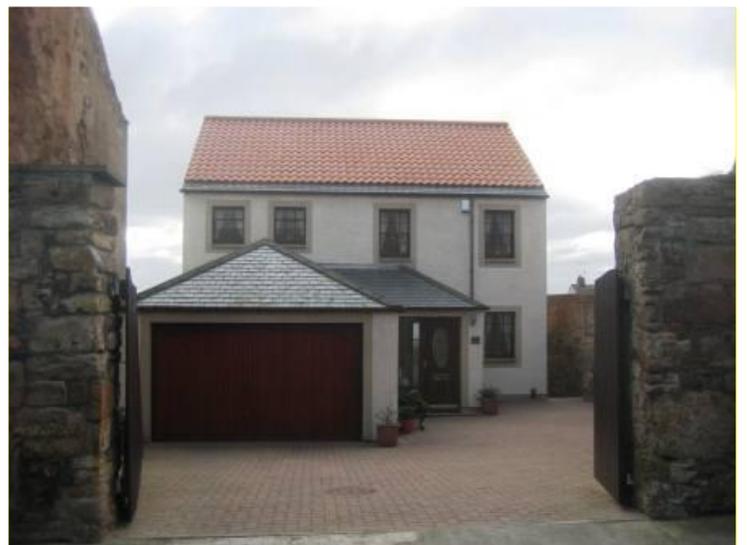
Architecturally confusing piecemeal use of traditional vernacular features. Note modern porch, fenestration, garage and absence of chimneys.

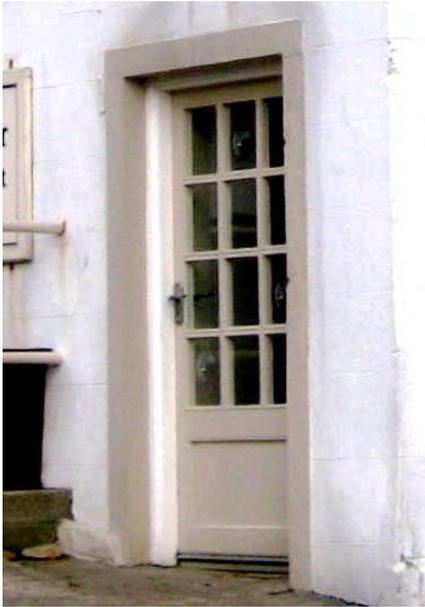
Non-traditional style glazed door.

Windows and doors play an important role in defining character, particularly in vernacular architecture where they are dominant elements. Inappropriate replacements can easily adversely affect this. The opportunity should be taken whenever possible to replace inappropriate windows and doors with well-designed traditional timber sash and case windows or solid timber plank or panelled doors.

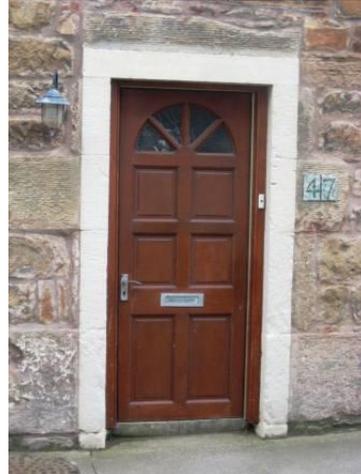
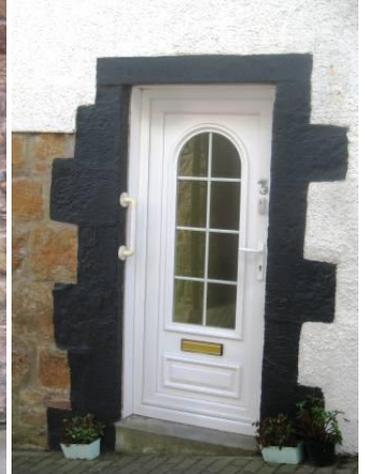
Above and left-examples from the conservation area of inappropriate non-traditional styles of door

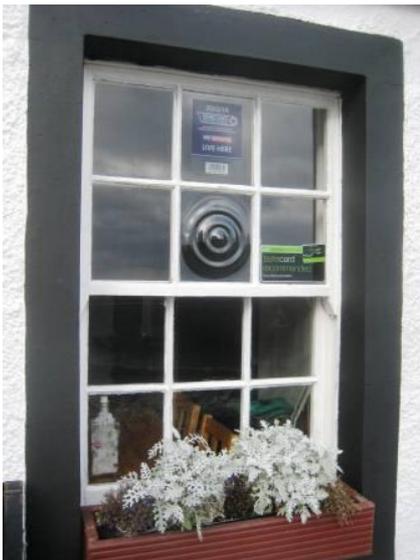
Non-traditional window design with imitation Crown glass and 'horns'.

Even where windows have been replaced with traditional style timber sash and case ones, the detailing may be inappropriate and detract from the significance. For example 'trickle vents' for double glazed windows are not a traditional feature and should be concealed if possible or avoided. 'Horns' on sash windows are not a traditional feature of multi-pane windows, which did not need this additional joint strengthening feature (allowing a full tenon joint), prior to the use of float glass in the mid-19th century. Similar considerations need to be applied to doors where inappropriate ironmongery or glazed panels can have a significant impact on the character and appearance.

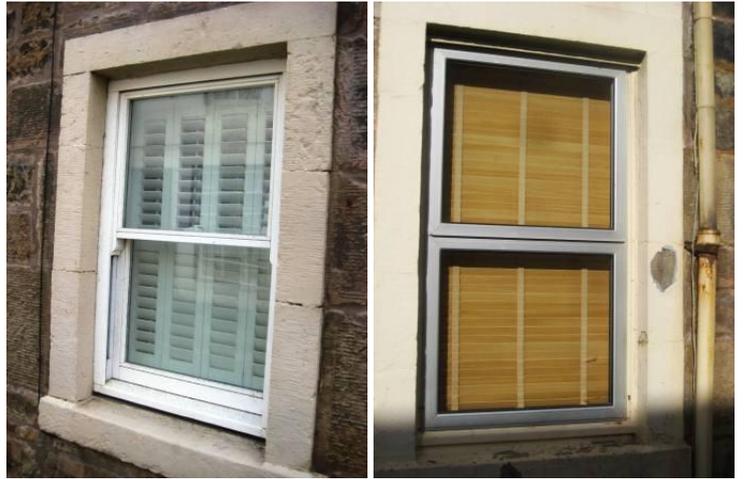
Above, below and left- examples from the conservation area of inappropriate non-traditional windows (design, proportions, detailing, materials)

Fife Council has published design guidelines on replacement windows which are available online on www.fifedirect.org.uk

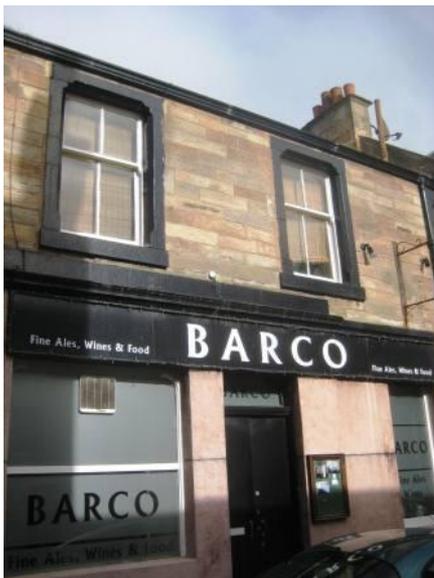
Traditional appearance of bar fascia with simple sympathetic lettering.

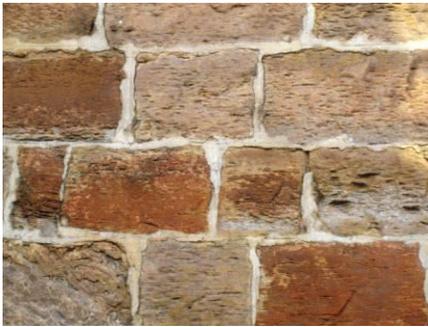
Example above of the adverse effect of cement mortar on masonry.

Modern cement mortars and renders have been inappropriately used on traditional masonry buildings, including listed buildings, throughout the conservation area. There is also widespread use of modern film-forming masonry paints. These types of paint and mortar are harmful from a technical viewpoint as they trap moisture within the masonry and accelerate decay. In addition to trapping moisture, cement-rich mortars and renders do not absorb moisture either directly or through drawing it from the less porous adjacent stone to allow it to freely dissipate over a large surface area. Instead the adjacent stone will absorb a greater proportion of the moisture. Depending on the location it may also absorb run-off from adjacent surfaces. The combined result will be the accelerated decay of the stone. Also aesthetically they are historically incorrect and do not protect or enhance the special character of either buildings or the area. Lime based paints and mortars should be used or breathable liquid silicate (mineral) paints.

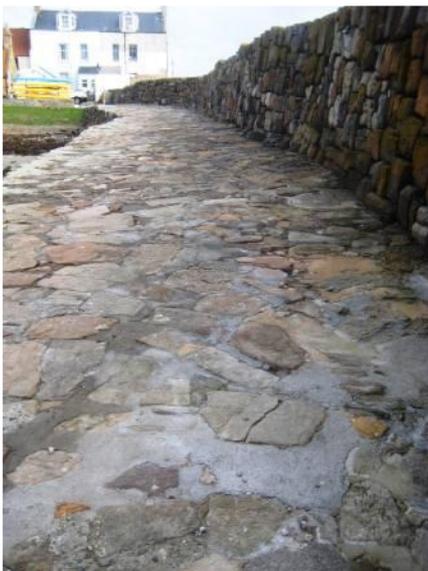
Modern cement used on the category B listed Cellardyke harbour

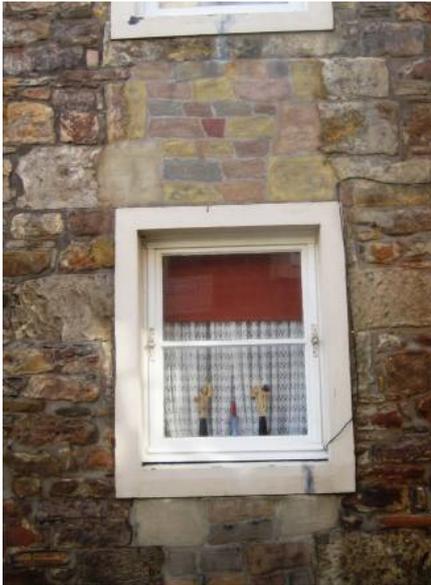
Coloured cement mortars used in attempt to imitate rubble masonry (George Street).

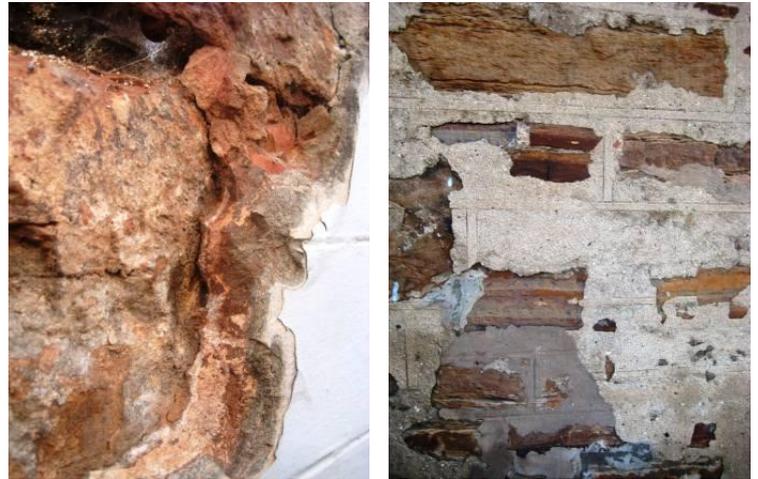
Above examples of the use of modern cement render on traditional sandstone rubble masonry (left) and pointing mortar (right).

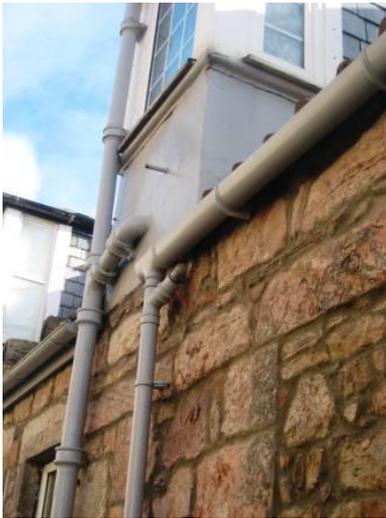
PVCu rainwater goods and soil pipes.

Some houses were restored in the 1960s under the National Trust for Scotland's Little Houses Improvement Scheme. Although the scheme was valuable in helping save many buildings, conservation good practice has changed and things would now be done differently in many cases. In particular traditional lime mortars, harls and colour washes would be used rather than the extensive use of wet dash modern cement renders and mortars and the use of brilliant white modern masonry paints. Other examples of the inappropriate use of modern materials in the conservation area are concrete roof tiles and PVCu

rainwater goods and soil pipes.

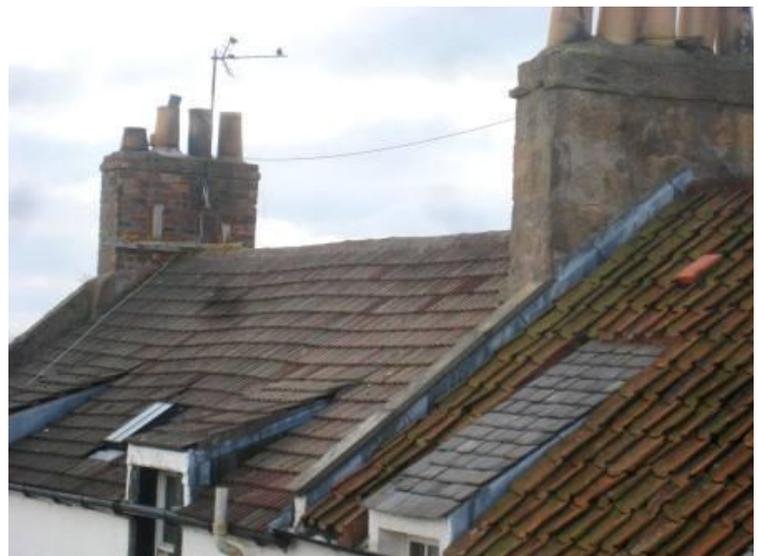
Modern concrete roof tiles on above left-hand roof. Contrast with traditional pantile roof to right.

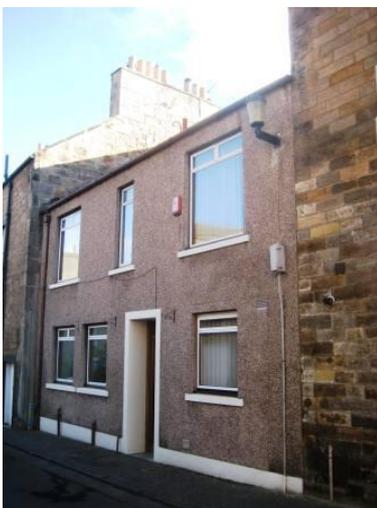
Modern and enlarged windows and dry-dash render.
