**CELLARDYKE CONSERVATION AREA APPRAISAL
and
MANAGEMENT PLAN**

**ECONOMY, PLANNING AND
EMPLOYABILITY SERVICES**

APPROVED JUNE 2015

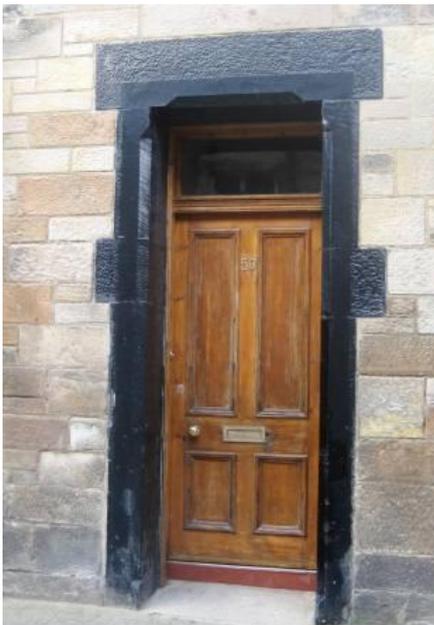
Modern varnish applied to a traditional panelled door.

Certain dark colours may be more appropriate for windows, having a historic precedent. External woodwork was not usually varnished and so is not generally an appropriate finish within the Cellardyke conservation area. In exceptional cases poorer quality external woodwork may have been painted to simulate a high quality hardwood. It may, in these

exceptional cases be acceptable to use external varnishes if supporting evidence can be provided.

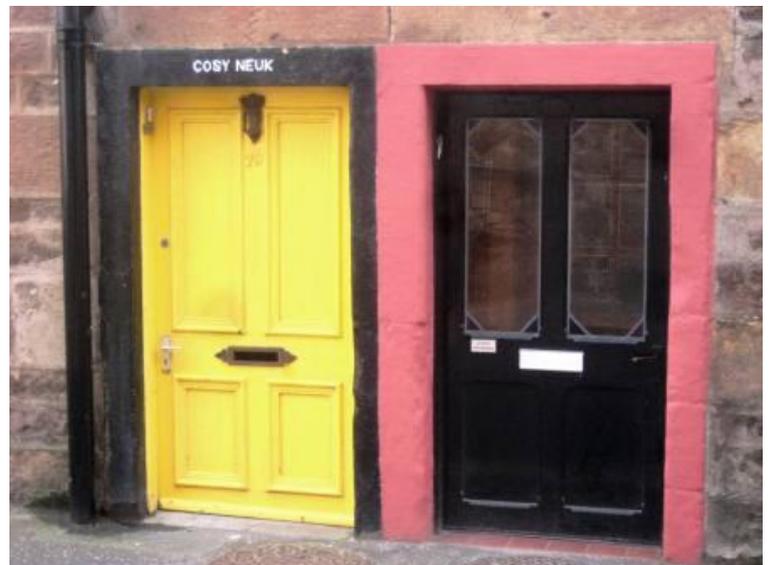
Examples of a non-tradition colours used on doors

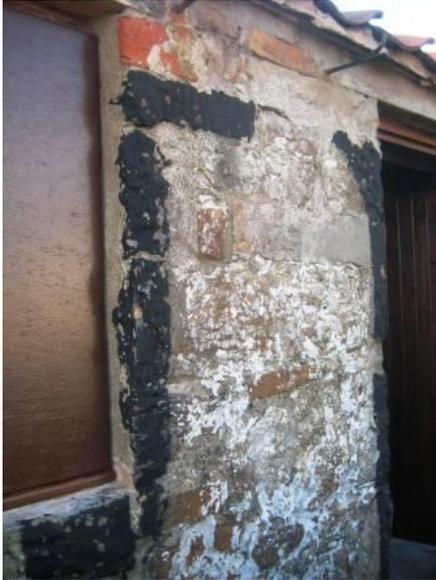
Remnants of a former black and white colour scheme (tar and whitewash) on a building with eaves latterly raised and used as a pig sty.

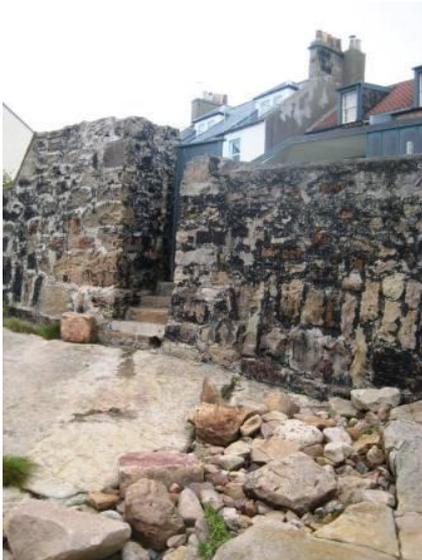
Traditional tar painted sea wall above.

A characteristic feature of Cellardyke, in common with other East Neuk fishing villages, is the use of tar as a masonry finish. Tar was readily available as a by-product of gas production and traditionally used in boat construction. It was also used to weather-proof sea walls and other exposed masonry. It was a cheap way to freshen-up high traffic areas such as wynd and pend walls.

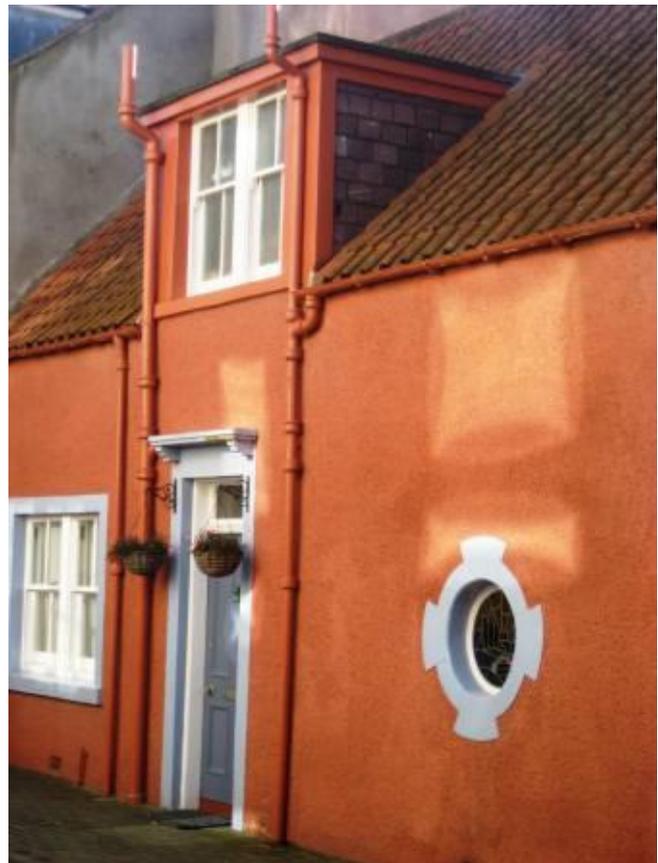
Example of a non-traditional colour scheme.

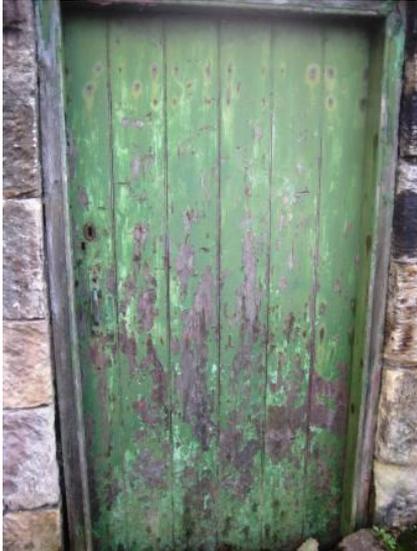
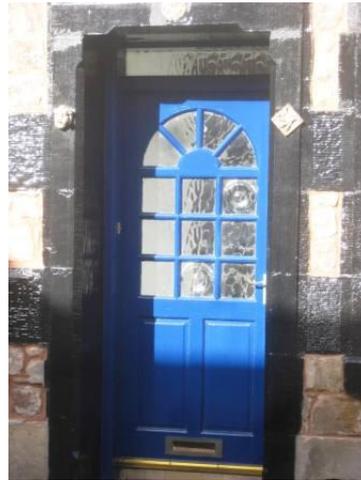
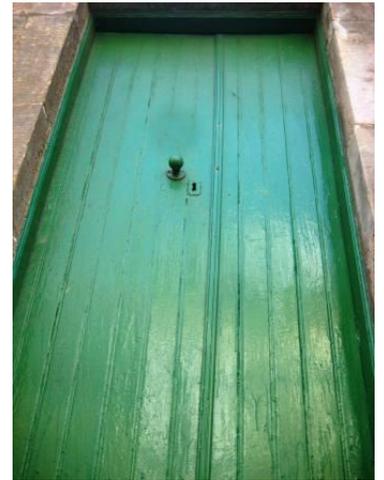
Contrasting examples of use of rich colours. Above left a non-traditional style door in a non-traditional colour. Right—an original door painted in a rich traditional colour and far left remnants of original paintwork in a similar colour.

Primary colours should be avoided for doors and for picking out margins although strong traditional colours in deep shades are acceptable for doors. The use of black for contrasting door and window margins is often considered traditional although this would have had a very different appearance to the modern intense high gloss blacks and whites so often seen.

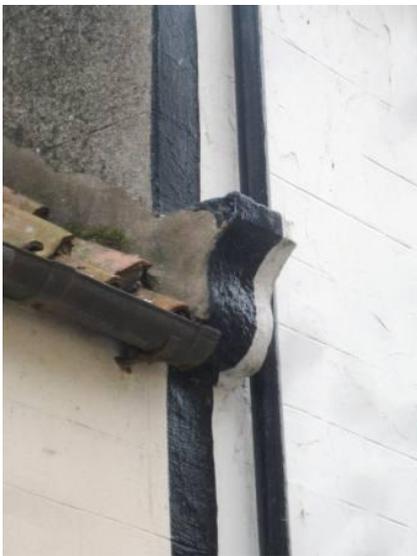
Insensitive paint treatment.

Unless stone is of poor quality or harled or rendered, masonry should not be painted. Modern film-forming paints should be avoided in favour of lime-washes or liquid silicate paints which allow the masonry to 'breathe'. An added benefit of lime based paints is they produce a less uniform, more historically accurate finish.

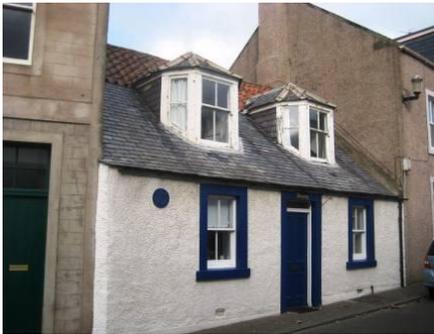
18th century category C listed cottage. Modern dry-dash render removed and pantiles added

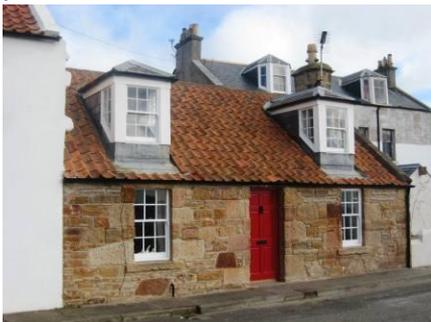
18th century category C listed cottage. Paint removed from masonry and dormers added.

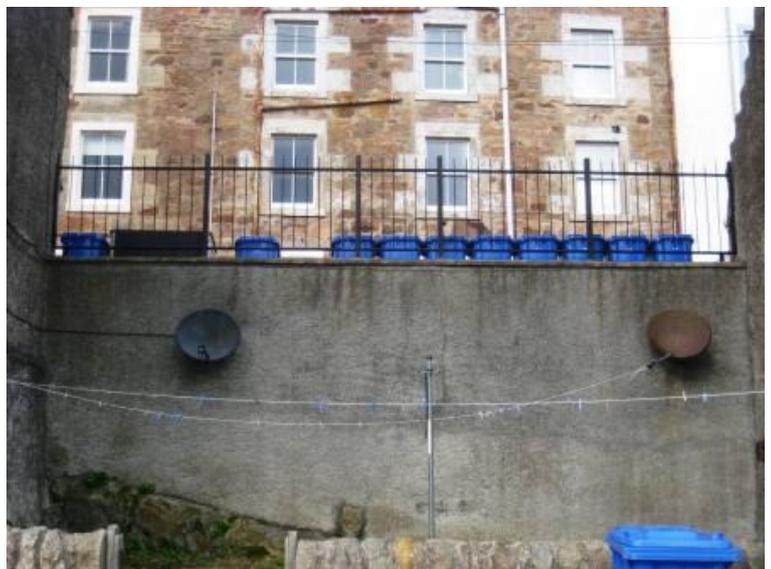
Prominent gap site between Dove Street and Shore Street at heart of picturesque harbour area. Note satellite dishes (and row of rubbish bins).

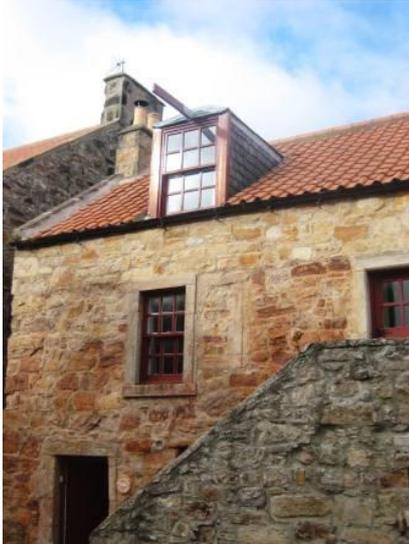
18th century category B listed house with the harl removed, and a second dormer complete with replica net hoist gantry added.

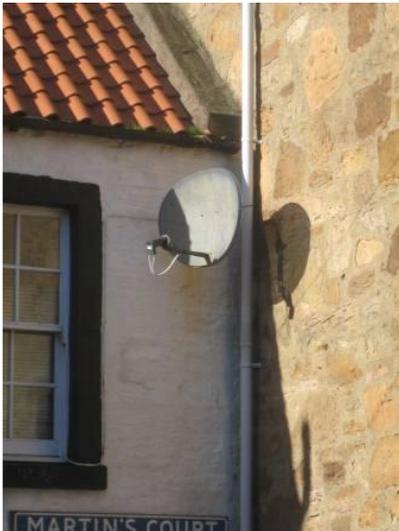
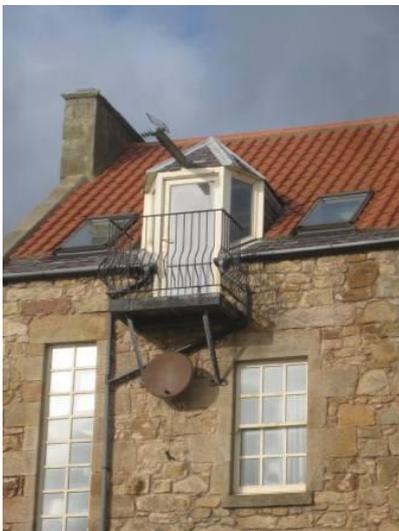
Satellite dishes - on building opposite Town Hall and below.

On a smaller scale, satellite dishes and even TV aerials, which are clearly modern intrusion diminish the historic character and can be seen throughout the conservation area. Similarly, additions such as security alarm panels, roof vents, hanging baskets, porches or carriage lamps need to be considered carefully to ensure that they are historically appropriate and do not adversely affect the historic or architectural character.

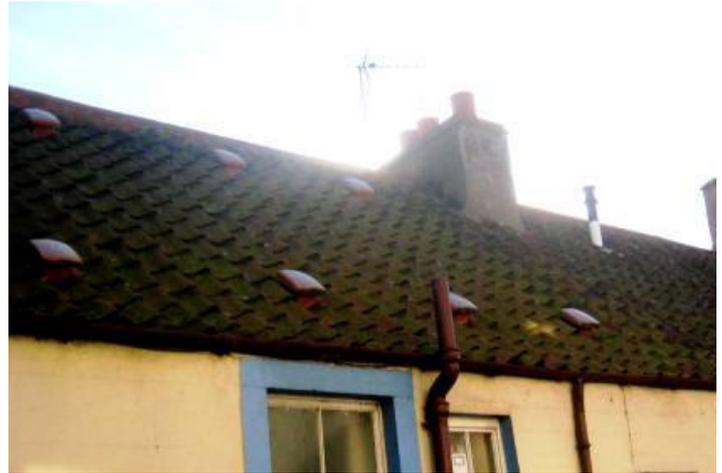
Conspicuous multiple modern vents on traditional pantile roof

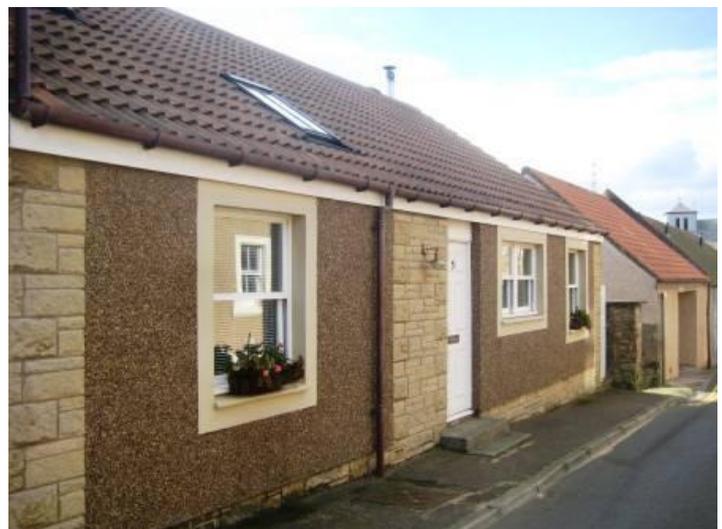
Traditional cottage with imitation stone cladding, dry-dash render, enlarged windows, PVCu door, modern sky-light, concrete roof tiles.

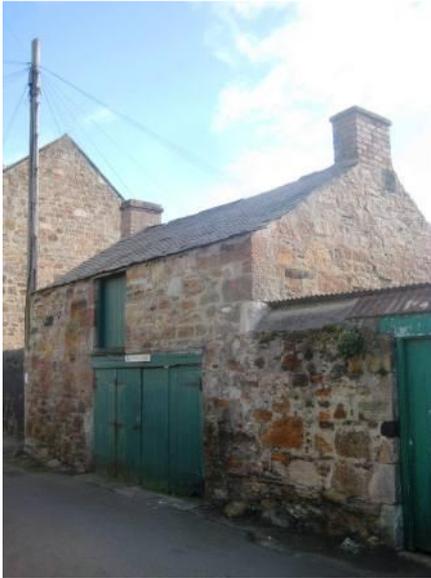
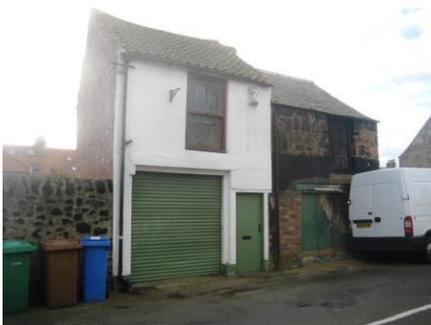
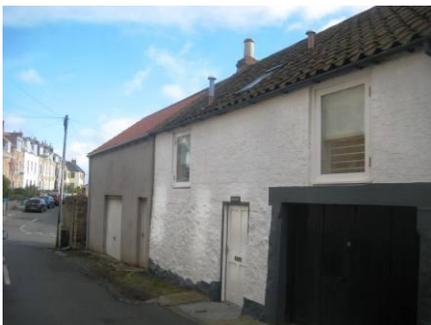
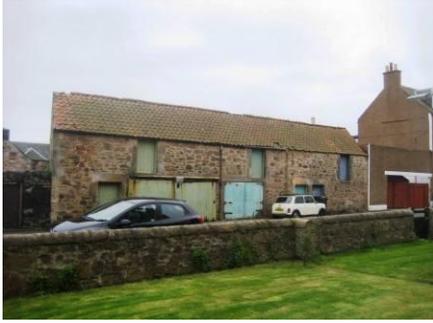
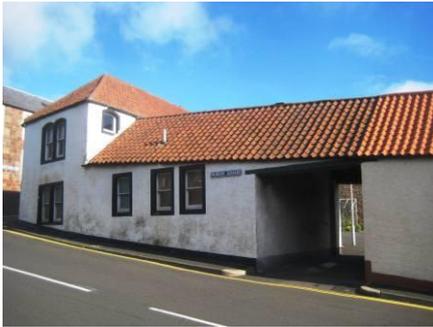
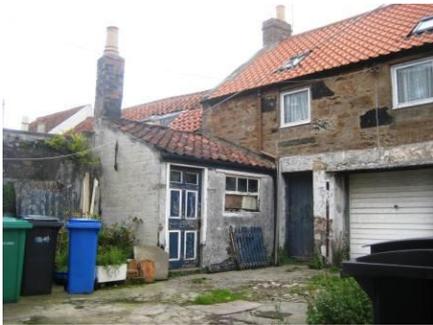
Former stores and workshops along School Road and East and West Forth Streets (above and below).

such a manner as to destroy any historic character. A similar process can be seen along West Forth Street and School Road. In each of these areas the buildings and the historic character of the streets as a whole have been significantly diminished by such inappropriate development.

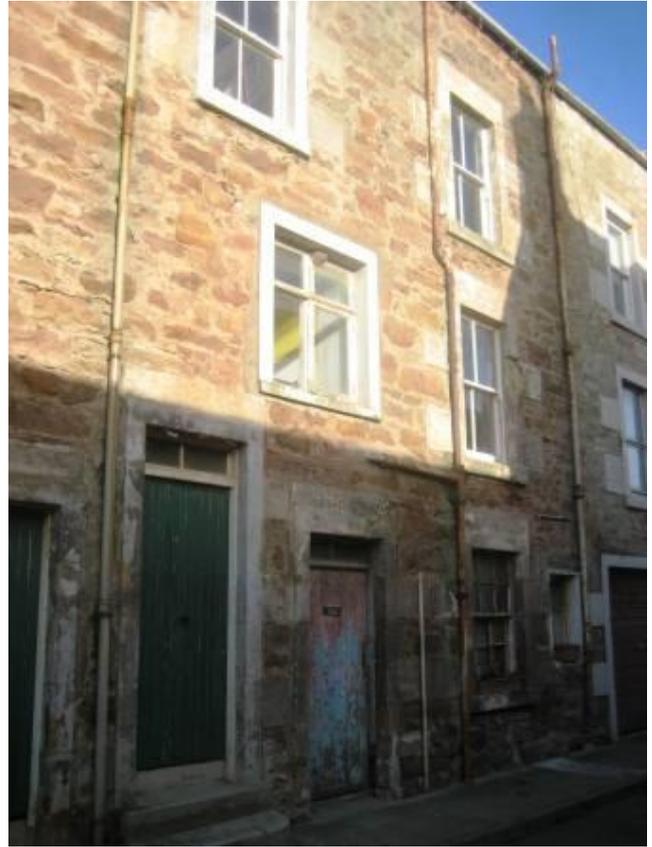
4 Dove Street on national Buildings at Risk Register.

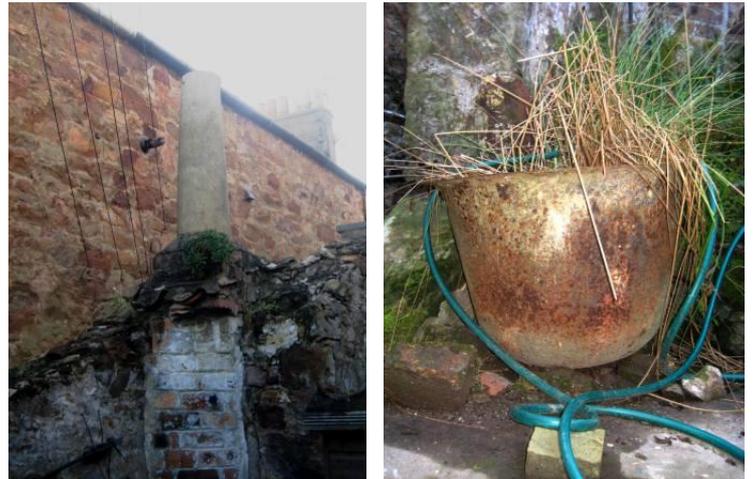
Before the availability of modern synthetic materials in 1950s removed the need, 'barking' the fishing nets was a routine activity (every few weeks during the fishing season). An outbuilding contained the furnace used to boil up a mixture of tar creosote and water, contained within a copper pot situated in the furnace's stone structure would have once been common. Originally oak or birch bark, then cutch from the east, and then alum or creosote was used to preserve the linen or hemp and later cotton nets. Creosote would have been a by-product of the local gas works in Anstruther Easter.

Remnants of former barking house-furnace flue and copper pot (right).

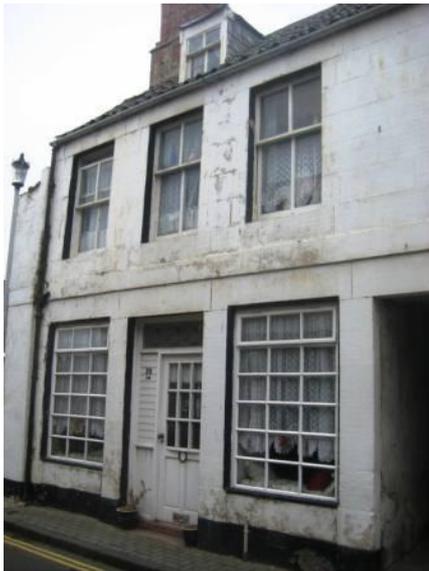
Former shop on John Street now in residential use.

For example, with less demand for local shops there is often pressure to convert former ground floor shops to residential use and to replace the shop windows with domestic style ones. This can not only change the character and appearance of the building but also results in a loss of diversity within the street scene and similar loss to the conservation area. Another example is along East Forth Street where the former fishermen's' sheds have had modern metal doors and PVCu rainwater goods added and generally so altered that they retain little of their original character. New garages have been built alongside and houses altered in
