**ST MONANS CONSERVATION AREA APPRAISAL
and
CONSERVATION AREA MANAGEMENT PLAN**

**ENTERPRISE, PLANNING &
PROTECTIVE SERVICES**

APPROVED JUNE 2013

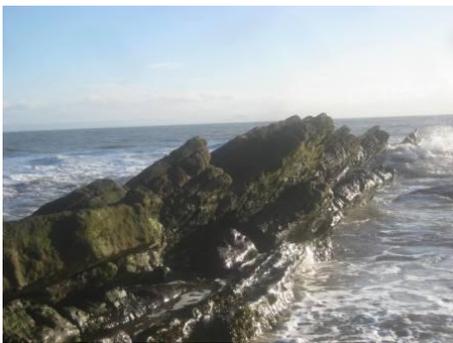
Unique local geology -steeply angled synclines near harbour.

The local geology (steeply angled synclines) produced natural breakwaters and a deep natural harbour. From the 14th century and into the 20th century St Monans was essentially a fishing village. Centred as it was on the harbour, fishing and boatbuilding had a direct influence on the development and character of the historic village which now substantially comprises the conservation area. From the 16th century until well into the 18th century St Monans had separate fishing and farming communities, the Lower or Nethertown and the Upper or Overtown respectively, the latter located just north of Braehead. A second area of industry was centred on the mines and saltpans to the east of the village. However these communities remained largely separate and there was little direct impact on the development of the character and appearance of the historic village.

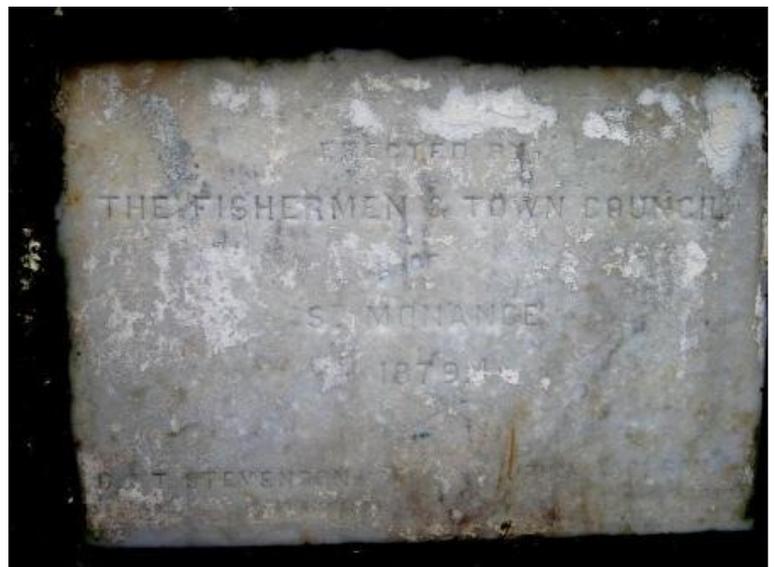
Plaque (above) built into the wave wall of the harbour west pier reading: "Erected by the Fishermen & Town Council of St Monans 1879". Commemorating the completion of the new Middle and West Piers.

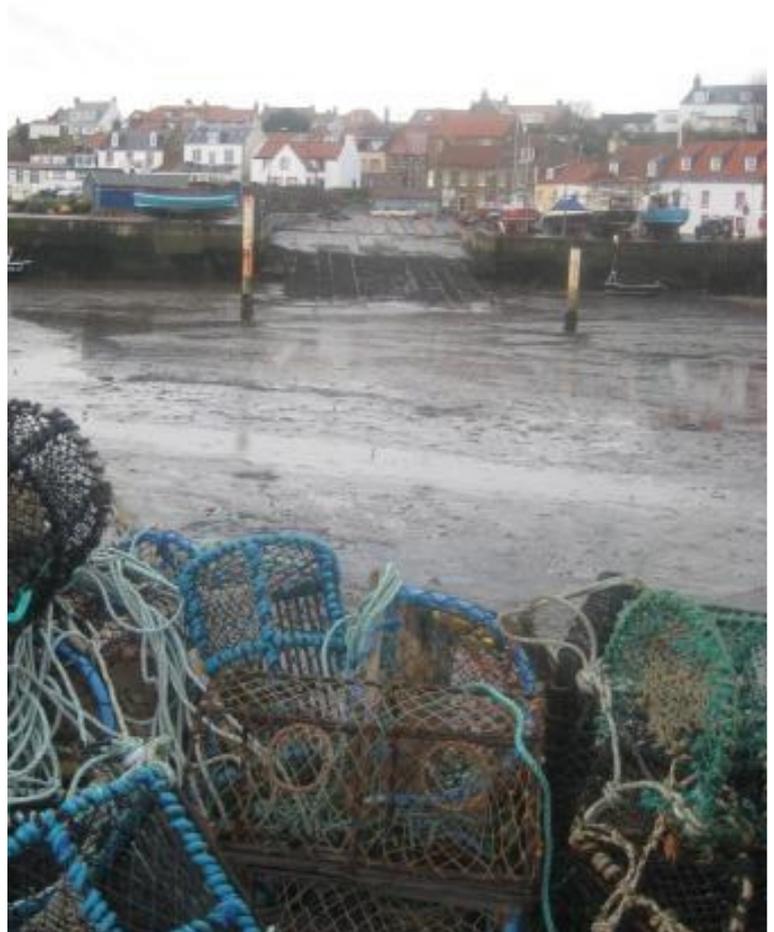
View across west harbour towards slipway

A deceptively old looking reminder of this important former industry is the large slipway in the north-west

corner of the harbour, built for Miller's boatyard only in the 1970s. Deceptive as the associated winch house looks much older with its pantile roof and re-used stone from the former Anstruther railway station.

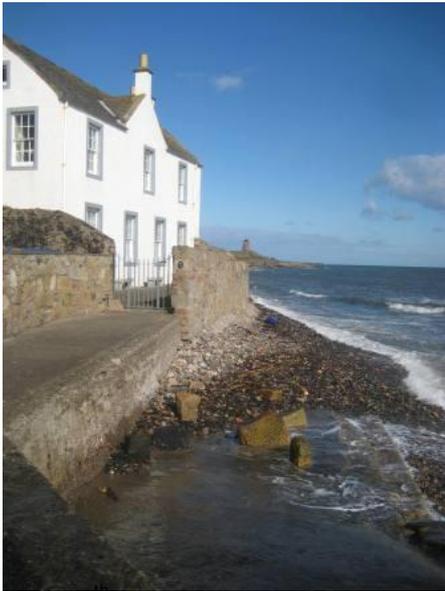
Early 19th century category B listed former parish school on the easternmost edge of village as shown on OS 1st edition map. Note the restored wind engine for the former salt pans in distance.

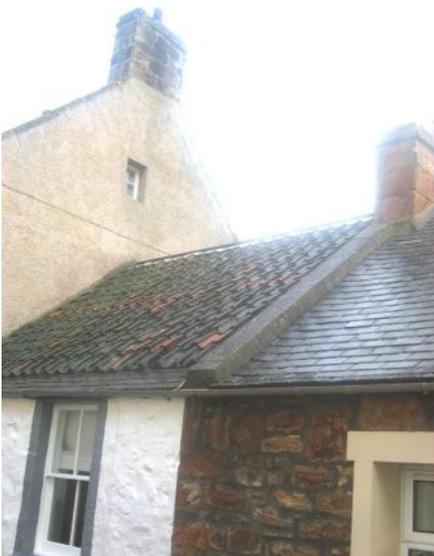
Typical mixture of traditional materials and finishes, adding diversity and interest. . Note unsympathetic PVC-u window to right-hand window and non-traditional brilliant white modern masonry paint left-hand cottage; and the rebuilt brick chimney head.

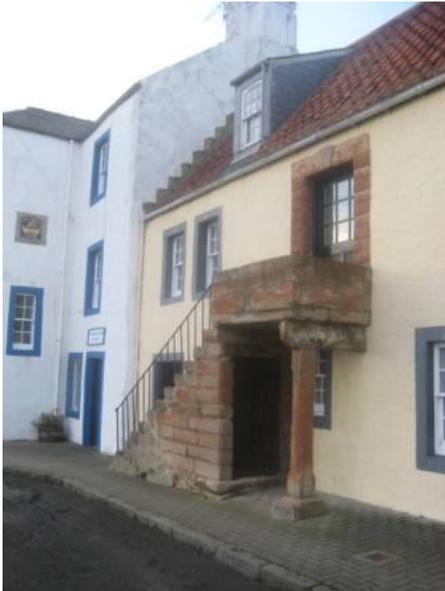
Forestair - 4 West Shore

Few of the forestairs, which many of the 18th and 19th century buildings would have had, survive, making those that do of particular significance. In 1851 it was noted that there were between twenty and thirty in the burgh. There are less than ten today (including three along West Shore). Living accommodation would often have been on the first floor with a boat store and workshop and sail store on the ground floor. In the late 19th century when fishing gear became bulkier, lofts were utilised and hoists installed. Few of these survive, but this traditional local detail continued into the design of the 1930s new housing in Gourley Crescent built by the council. There is even a reminder of this characteristic local feature in the architecture of the school which has a corresponding gable projection.

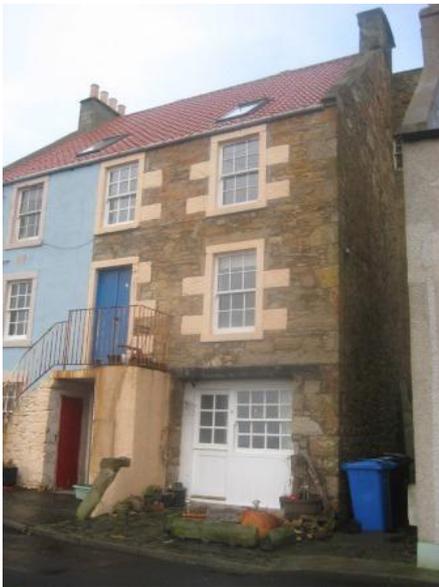
Converted boat store and sail loft at East Shore.

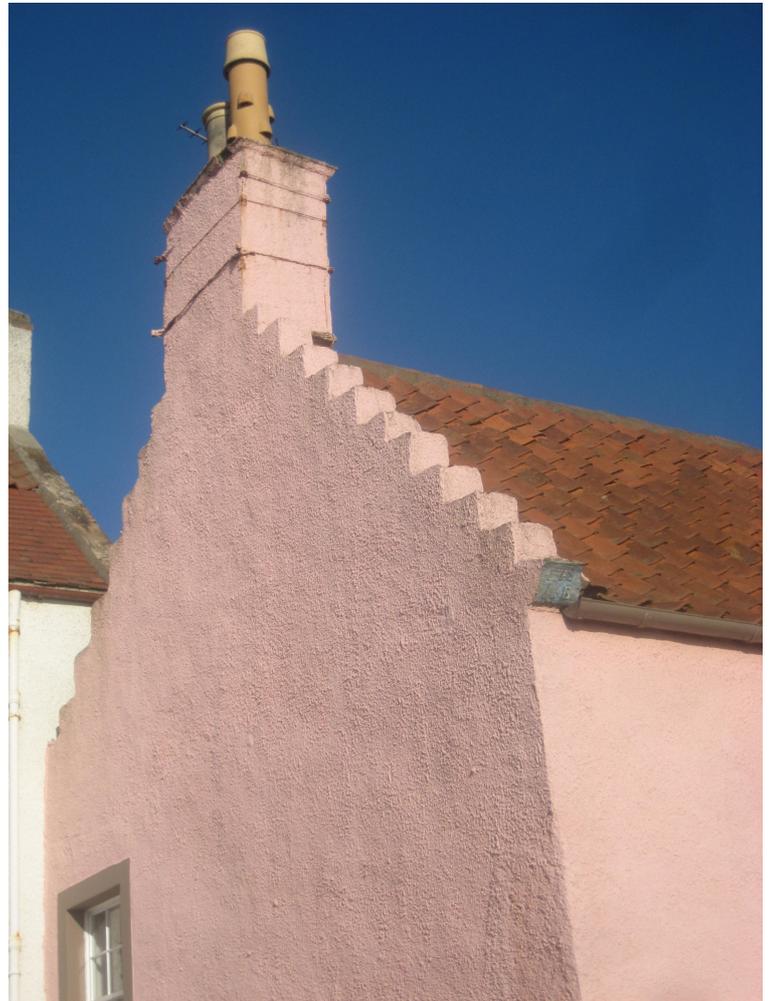
Pantiles, crow-stepped gable, skew-put and thackstone.

pantile roofs. This detail is a feature of many vernacular building in Fife. The function is not known for certain but was probably to provide better rain and wind protection over the eaves and wall heads. Another benefit would have been to spread and slow the rain water run-off from the pantile roof to allow it to be better caught in the gutters.

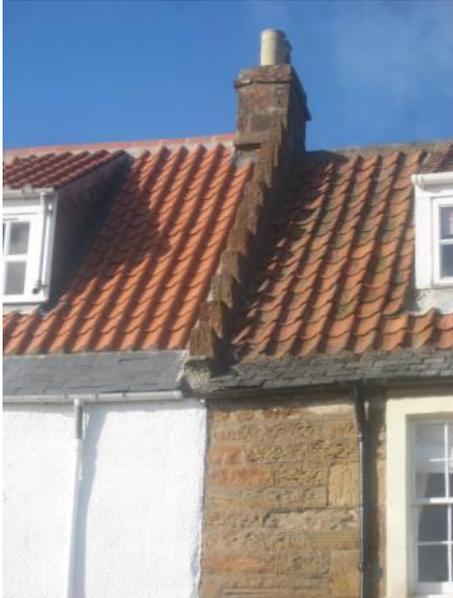
Contrasting old and new slate easing courses to pantile roofs.

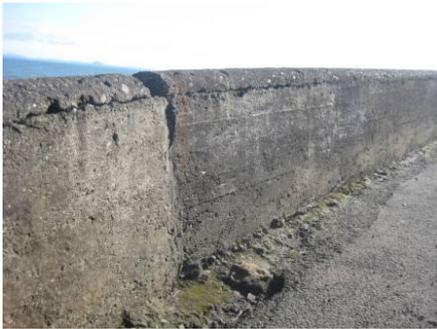
Shuttered concrete wave wall along West End.

lighthouses and is seen elsewhere around Scotland where the herring fleet also operated. Shuttered concrete wave walls can be seen along West End and the harbour front.

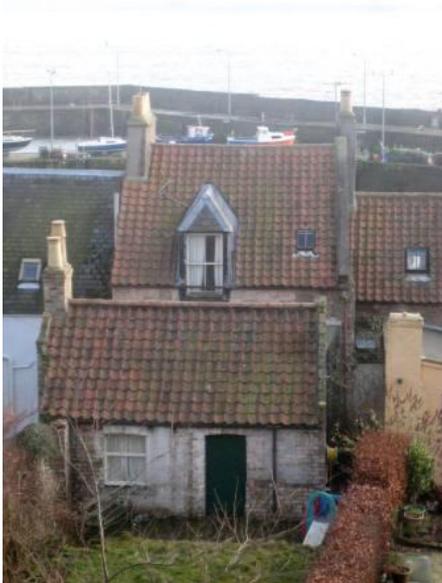
Some have thackstones, a reminder that they would originally have been thatched. This is an important detail which is usually lost when chimneyheads are re-built or removed. Some roofs have managed to avoid the addition of rooflights or dormer windows although many have seen the addition of these later features.

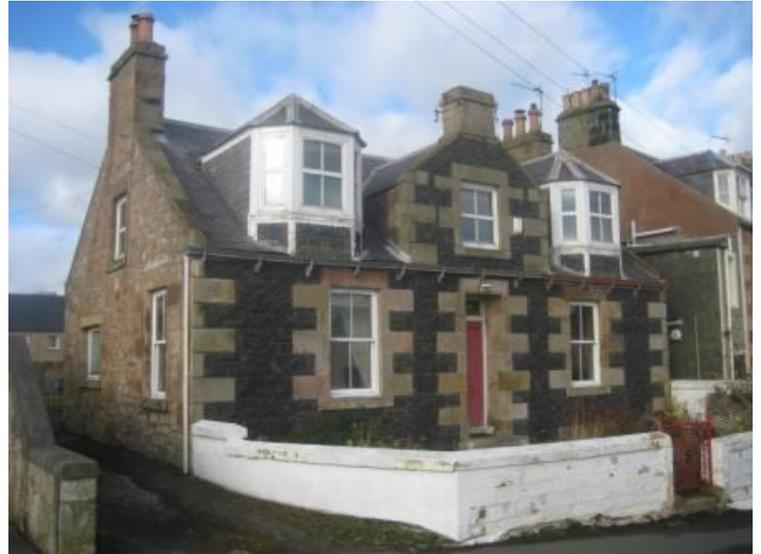
Unlisted 5 Braehead is a fine example of cherry coked whin rubble masonry skills.

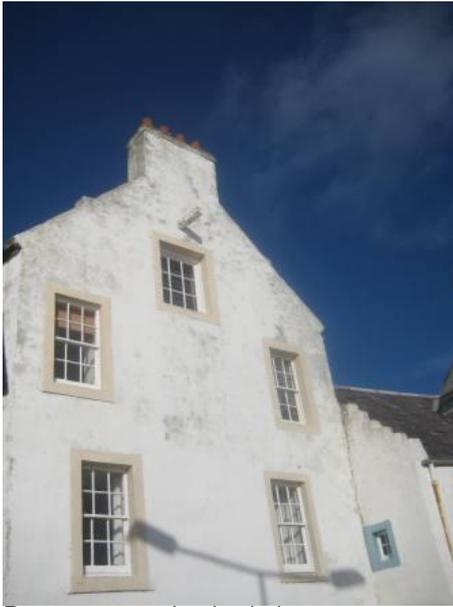
Rare extant projecting hoist gantry on the gable of 4 and 5 Mid Shore.

Although renovated in the early 1970s this substantial 18th century house retains much of its original character. It occupies a prominent position on the harbour front with both front and gable walls highly visible. There are some interesting details such as the gable hoist gantry and the central-step skews.

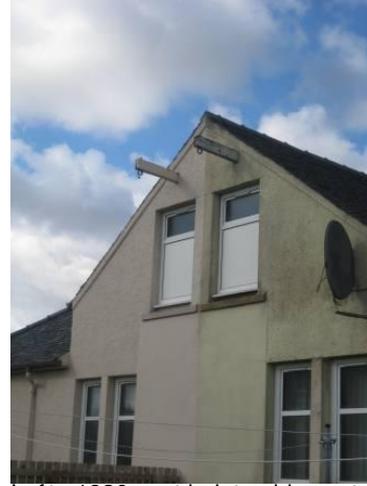
Left - 1930s net hoist gable gantries. Right – 1980s school.

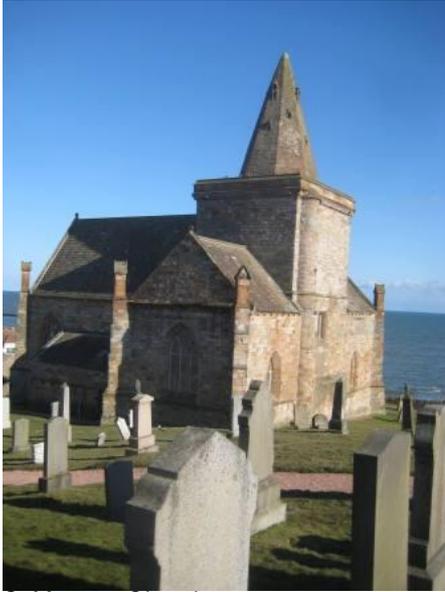
St Monans Church

Category A listed

In addition to its importance as a building, as reflected in the category A listing, this building is significant for its contribution to the story of the origins and development of the village. Due to its size, architectural style and prominent position it adds much visually to the character of the conservation area even though located on its western-most edge.

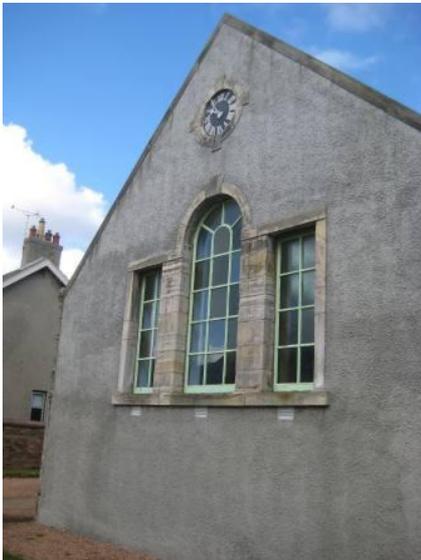
Parish Church Hall, Station Road

Category B listed

Also located on the edge of the conservation area, though to the north, this modest relatively modern building (1913) is significant for its Sir Robert Lorimer design and vernacular detailing.

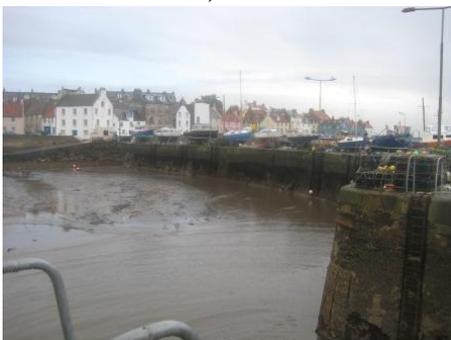
St Monans Harbour

Category B listed

The significance of the harbour cannot be overstated. Not only is it important in the story of the development of the fishing and boat-building village but it continues to visually provide the conservation area with its focus and identity. Although the structure is architecturally modest it incorporates from a harbour engineering viewpoint various interesting features. Its sensitive maintenance and repair is essential to protect this (ref. Buildings at Risk section of this appraisal).

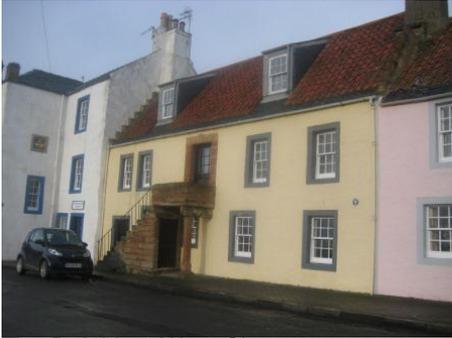
The Dolphin 4 West Shore

Category B listed

This is important as a good example of its type. It has a range of Fife vernacular features. Although it has had dormers added and the colour scheme is

inappropriate it still retains the now rare extant forestairs. It was also one of the first of a number of houses in the conservation area to be restored under the National Trust for Scotland Little Houses Scheme. It further influences the character of the conservation area due to its central position within the harbour-front.

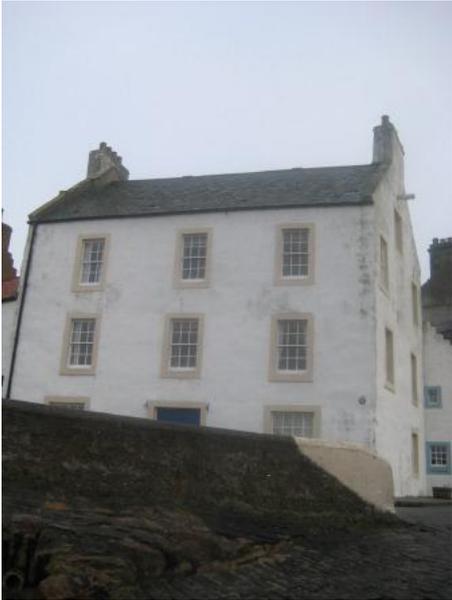
4 and 5 Mid Shore

Category B listed

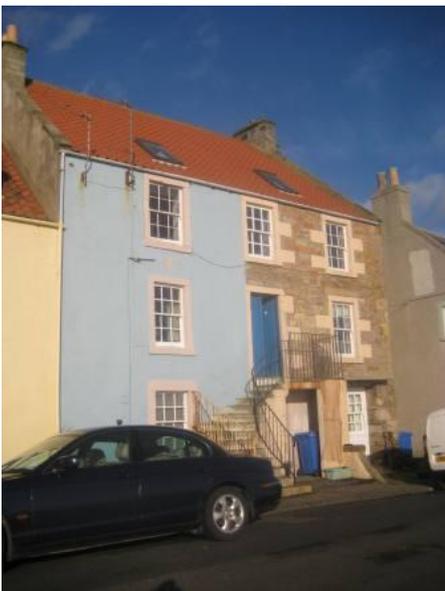
4, 5 and 6 East Shore

Category C listed

This late 18th century former Relief Meeting House was heightened as a house in the mid-19th century. It has been substantially renovated and some of the significance diminished by the addition of rooflights, the application of render and blue colour of half only of the front elevation and treatment of the former boat store. However, it still retains a number of interesting and now rare features.

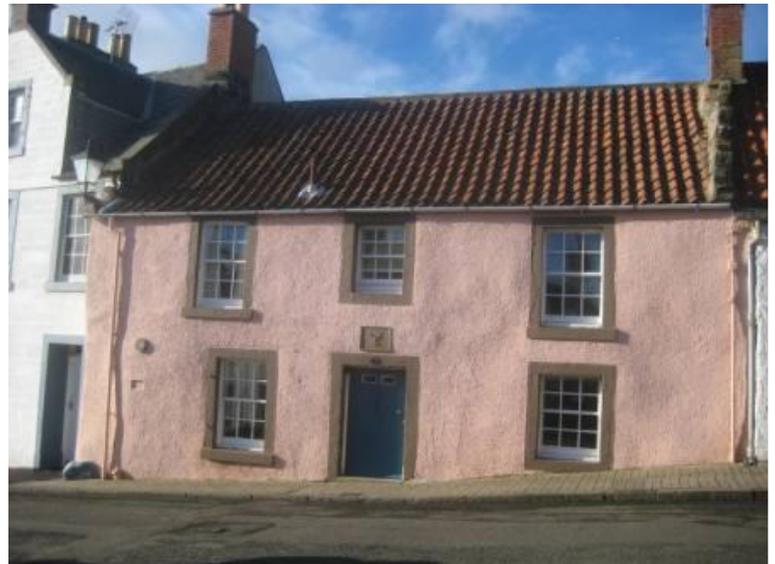
19 Forth Street

Category B listed

The significance of this 18th century house has been slightly diminished by the re-built brick chimney

heads, the unsightly vent pipe projecting through the front roof slope and the render painted in a modern pink colour. It is still a good representative exemplar for its type.

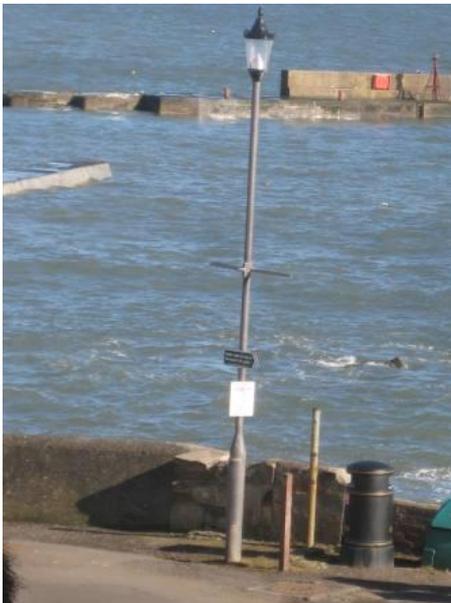
"Heritage range" lamp on a tall modern steel column and PVC-u waste bin.

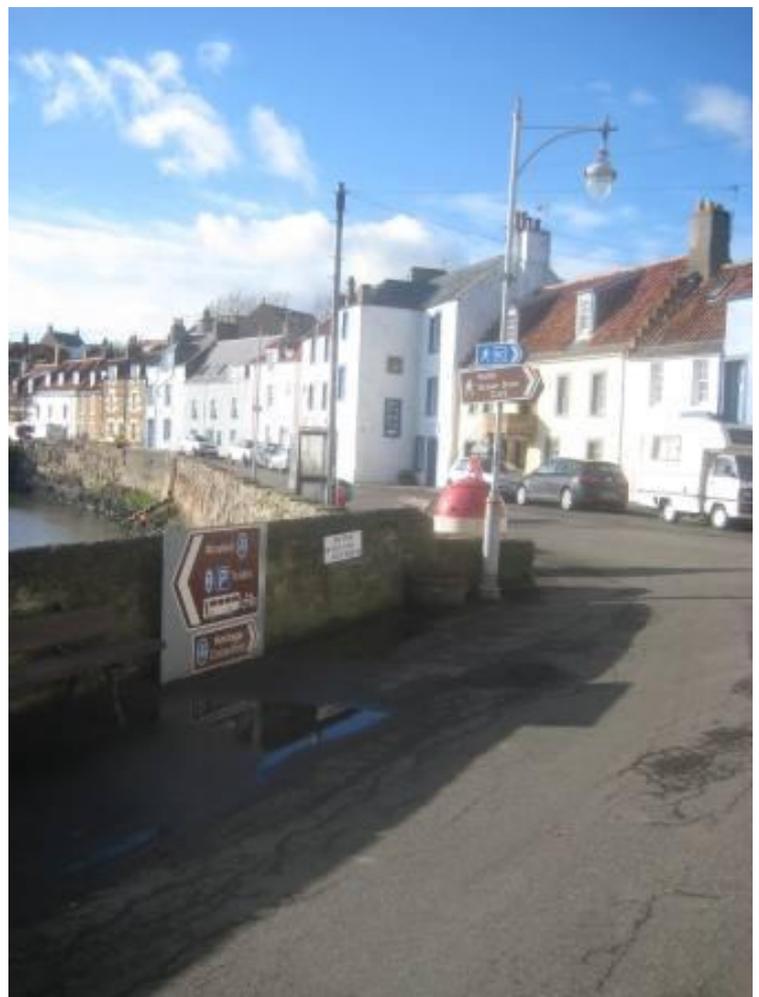
Signage along West Shore. An example of the good multiple use of signs and columns to reduce clutter and impact on the historic character.

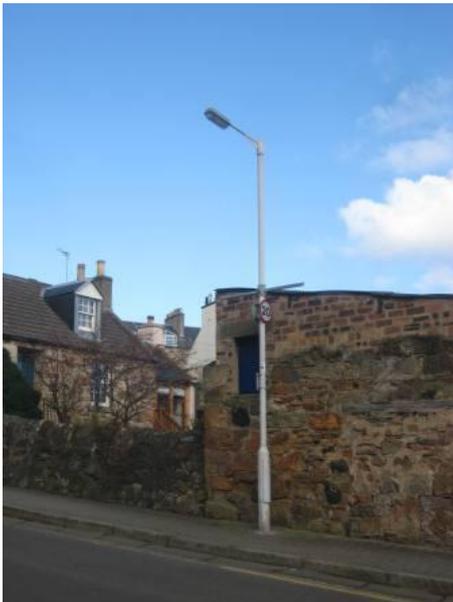
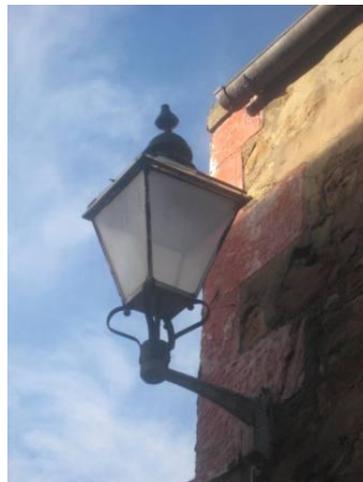
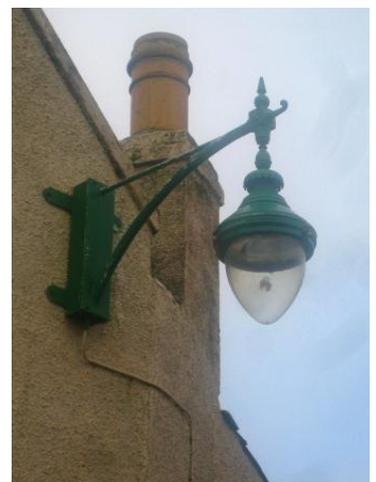
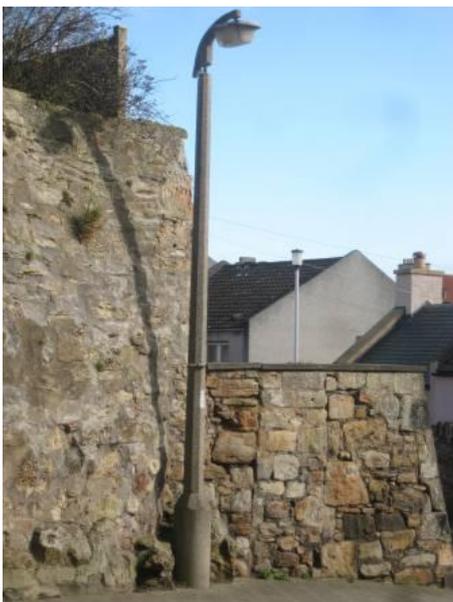
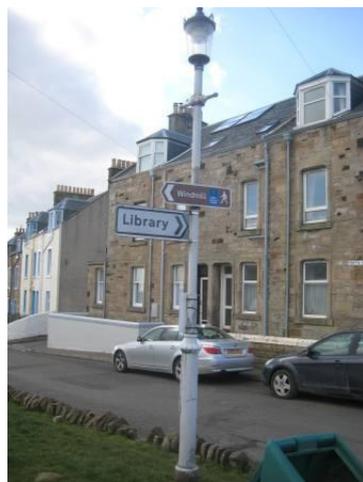
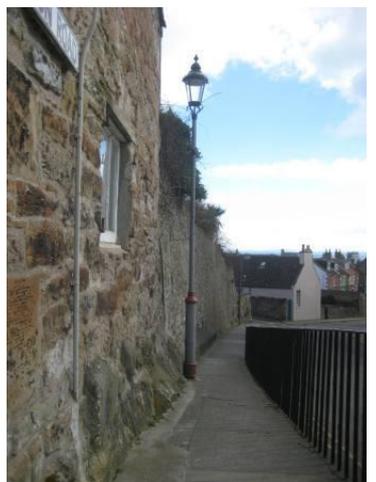
In St Monans conservation area any historic street lighting there may have been has been replaced through the 20th century with the current more utilitarian steel columns of hollow circular section some with modern lamps or others with ornate reproduction lamps (see left and below). There are at least half a dozen different designs within the conservation area, some of which are in disrepair. The styles range from tall modern minimalist style ones round the harbour and on Station Road to ornate reproduction Victorian ones. The different styles of reproduction lamps have no historic precedent and contribute little to the authentic character of the conservation area. The colour of light and brightness can also affect the night-time character of the conservation area, though this was not assessed as part of the appraisal.

Examples (above, below and left) of the many different styles of street lamps found in the conservation area.

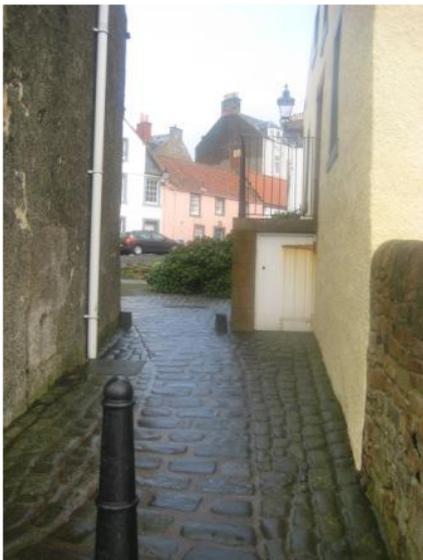
Re-laid sets and new bollard. Set in cement with much wider than traditional joints.

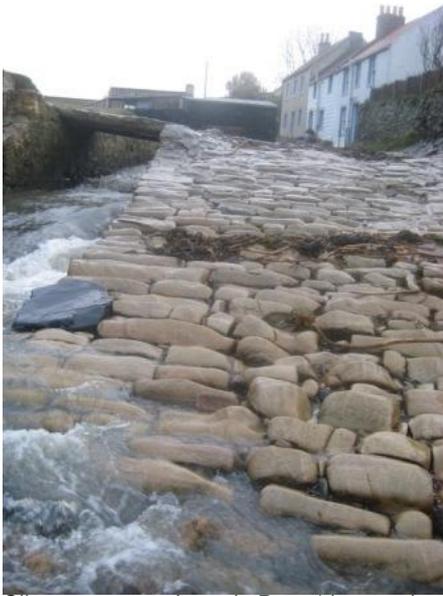
Slipway next to Inverie Burn (the nearby remains of what could be a former associated jetty or pier are revealed at low tide). The slipway is at risk of storm damage and loss. The mono-slab, Category B listed bridge in the background has recently been lifted and damaged by storm waves.

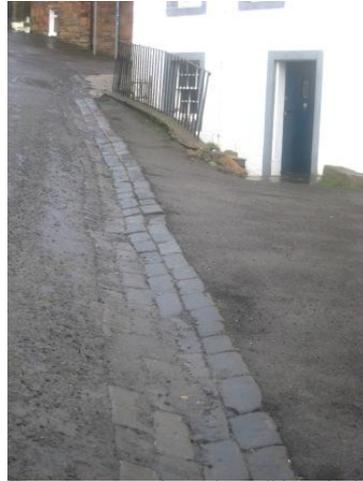
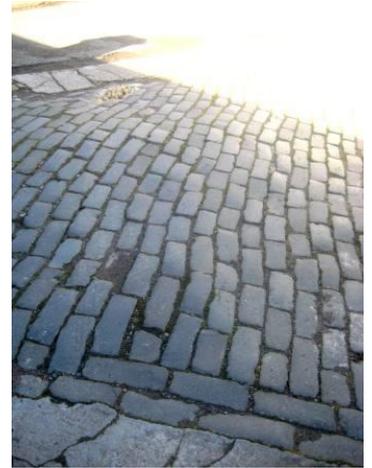
if anything, cobbled or whinstone spalls or horizontal strips in front of buildings. Settpaving was expensive and used selectively for high wear areas.

Extant examples of traditional whin sets.

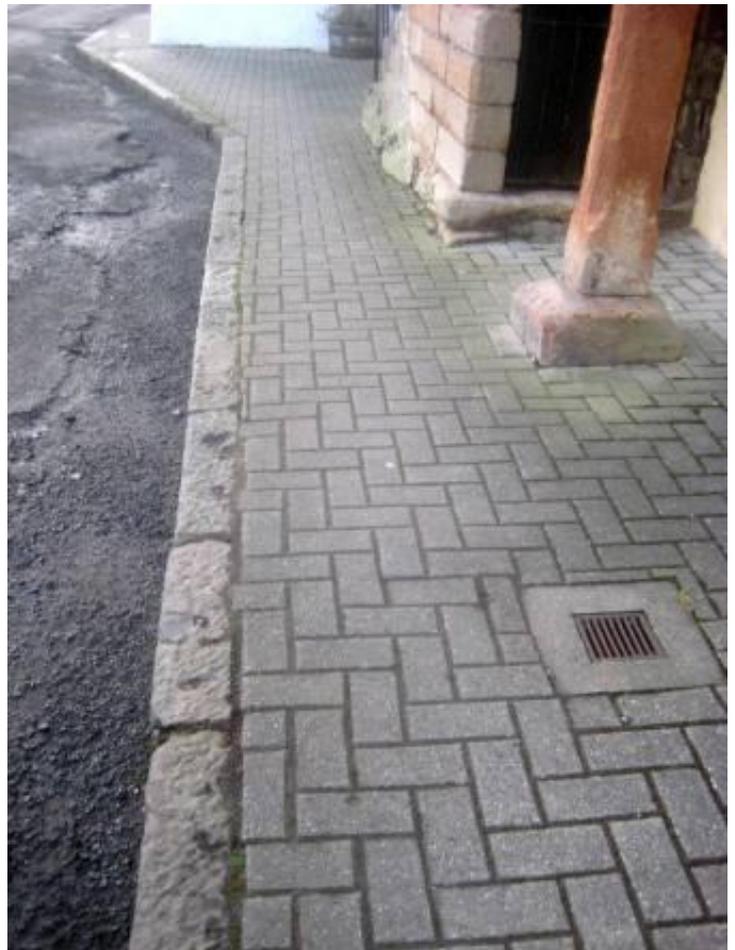
Modern concrete block pavements laid in a herringbone pattern.

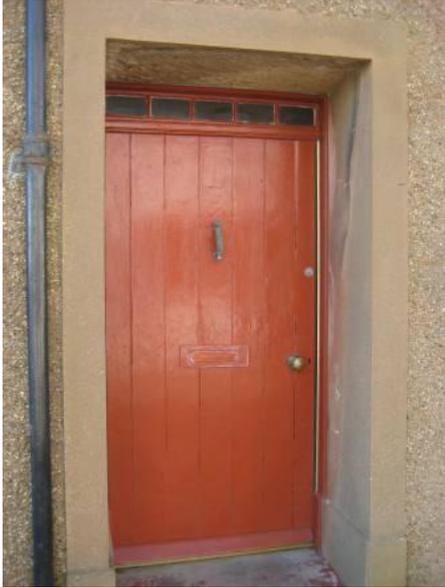
Surviving materials and details, as for doors above, are valuable in informing the appropriate choice of design.

Surviving materials and details, as for example the door seen above left, are valuable helping inform the appropriate choice of design. The tenement above left, now in different ownerships, shows different designs of door, colour scheme and a

variety of door furniture. If a letter slot, not contemporary with the building, is needed for example it can be disguised as illustrated on the door shown above (p34, top left).

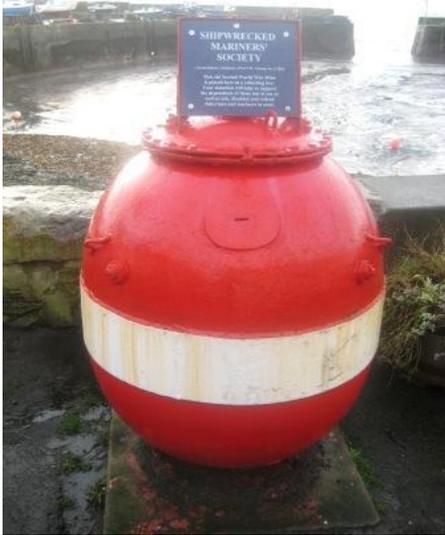
A former sea mine used as collection box for the Shipwrecked Mariners Society. Once much more common they are now rarely seen.

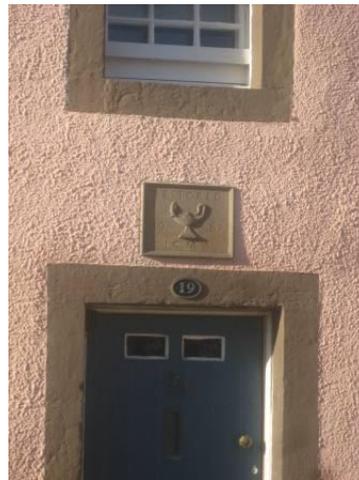
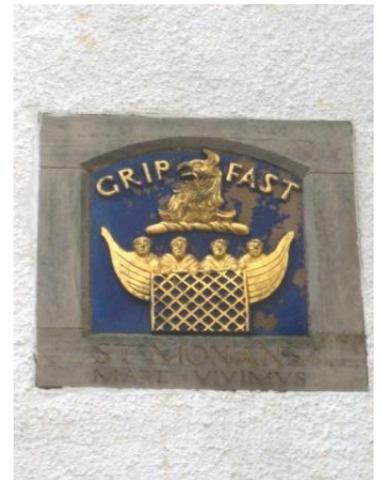
New carved stone panels on left 19 Forth Street and right 5-7 West Shore

A number of traditional looking new features have appeared on listed buildings in recent years. These can be sympathetic and enhance the character and appearance of the building and the conservation area without detriment to their historic or architectural significance. Great care however needs to be taken and any prospective future additions assessed on their own merits. Whilst they may be sympathetic, any new additions should not confuse or mislead the reading of this significance. Original fabric and any new addition to the building

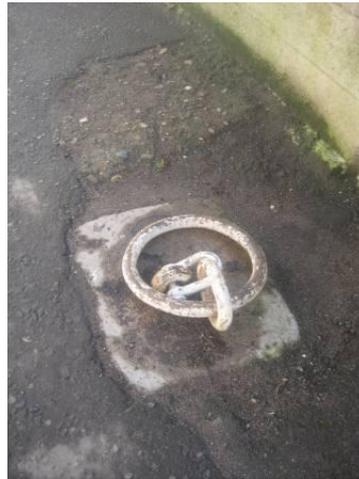
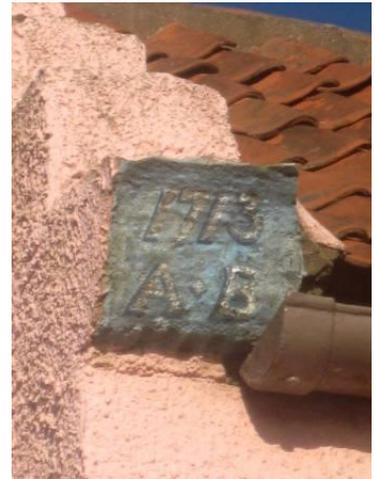
Left Mooring ring at West Shore harbour-front. Right painted skewput at 1 and 3 Forth Street

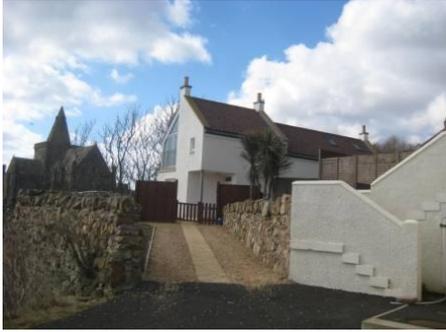
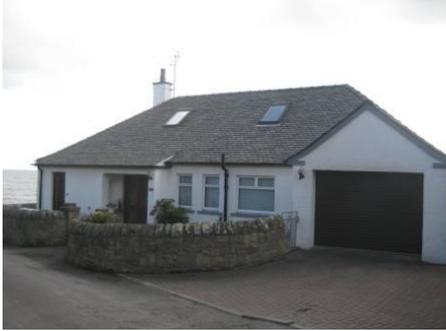
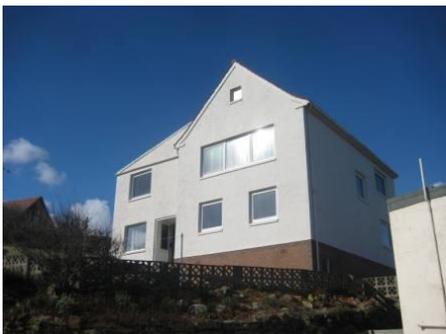
Above and below: a selection of examples of modern residential development within the conservation area.

Within the conservation area there are modern, post-war examples of infill, re-development and new development. Some make no attempt to be ‘of their place’ and others try too hard to look traditional. The better examples reflect the principles in ***New Design in Historic Settings*** and whilst clearly modern are harmonious with their surroundings.

New interventions in historic settings do not need to look ‘old’ in order to create a harmonious relationship with their surroundings. It is usually best not to try to replicate traditional vernacular features or introduce new ones which risk ending up as pastiche. The orientation, building line and density, proportion of garden ground, treatment of boundaries, building scale and mass, fenestration patterns, colours, materials and architectural paradigms used should be sympathetic and reflect the character of the place even if the building is clearly new.

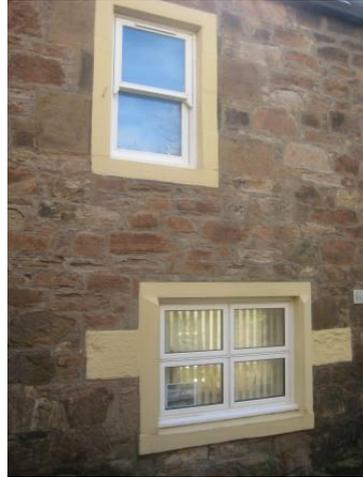
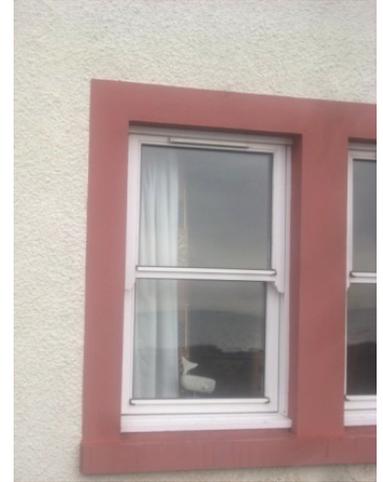
Left and above – examples of PVC-u windows and doors in the conservation area. Non-traditional: high gloss brilliant white finish; frame proportions; features (e.g. trickle vents and 'horns'); detailing (glazing beads); glazed doors.

Even where windows have been replaced with traditional style timber sash and case ones, the detailing can be inappropriate and detract from the significance. For example ‘trickle vents’ for double glazed windows are not a traditional feature and should be concealed if possible or avoided. ‘Horns’ on sash windows are not a traditional feature of

multi-pane windows, which did not need this additional joint strengthening feature (allowing a full tenon joint), prior to the use of plate glass in the mid-19th century. Fife Council published design guidelines on replacement windows are available online on www.fifedirect.org.uk.

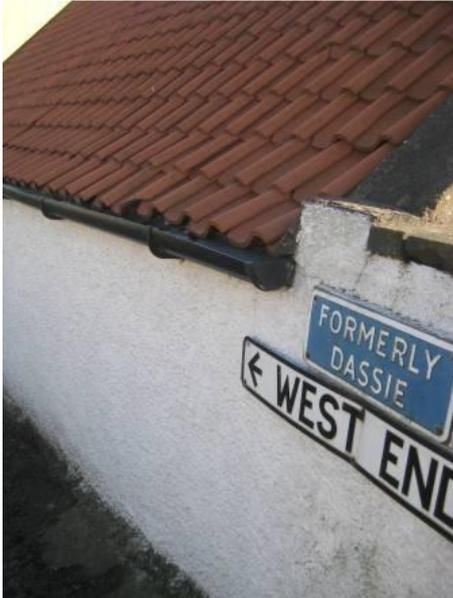
Plastic rainwater goods.

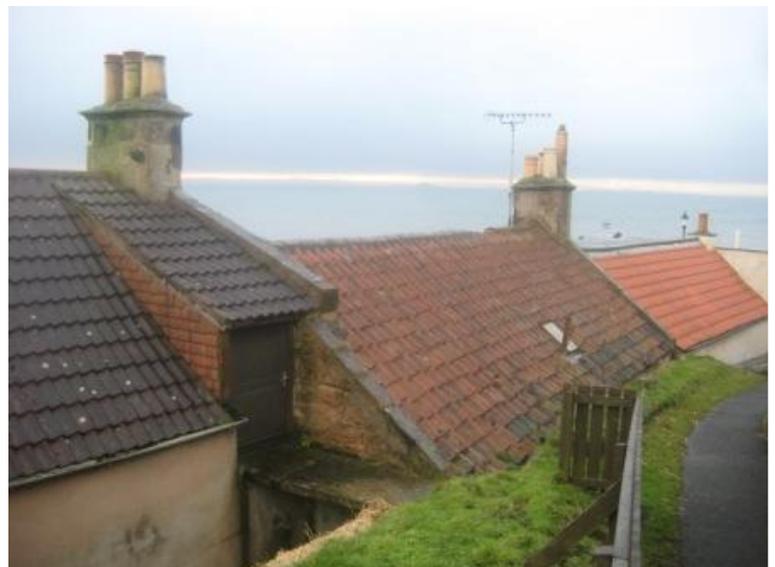
Modern concrete roof tiles far left roof.

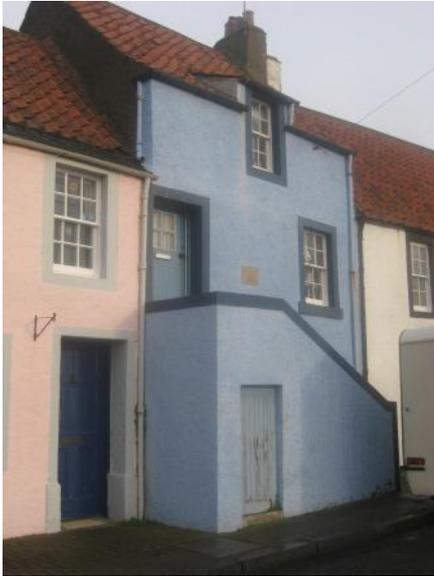
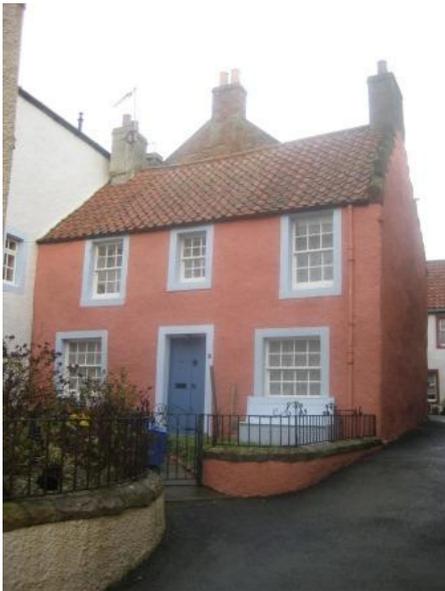
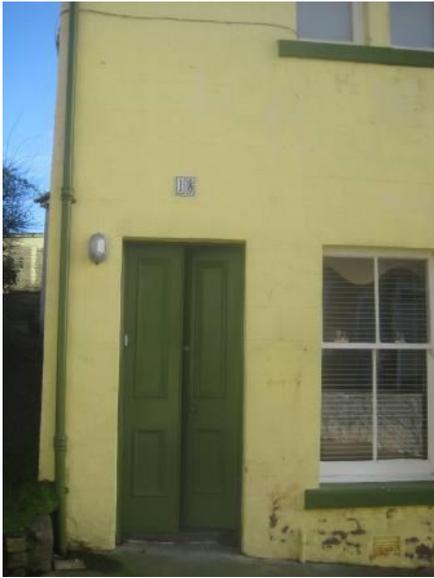
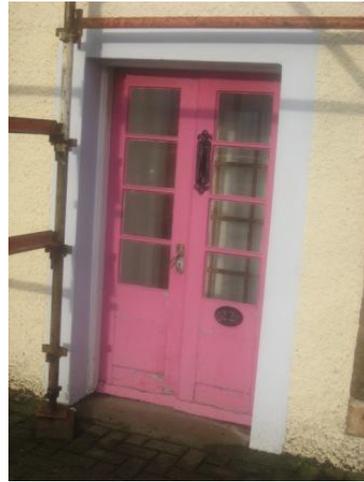
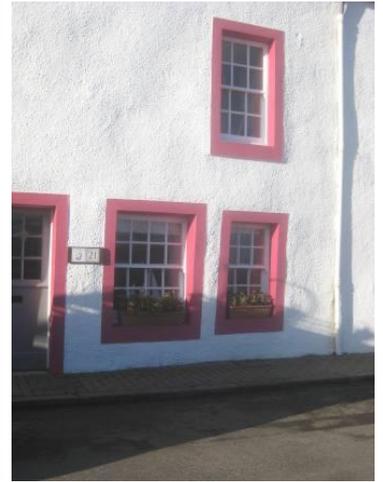
Examples above and below of some of the many non-traditional colours used throughout the conservation area.

The choice of colour can greatly affect the character of a historic building or area. Within the conservation area brilliant white and other colours, which were not historically available, are widely used for external renders, window and door margins; quoins and woodwork. Off-whites (not creams) are better for windows although certain dark colours may be more appropriate, having a historic precedent. Pigments for lime-washes may have been derived from a range of animal, vegetable or mineral sources, provided that they were alkali resistant. Lamp black and natural earth pigments were commonly used in the past as they were cheap and readily available. Natural impurities in the local limestone used for producing the slaked lime for the lime-wash would have produced various off-whites, but not the brilliant whites seen today.

Care needs to be taken to avoid non-traditional colours which have no historic precedent and may detract from the special character of the area. For example, blue, which was available as a lime resistant colour derived from French ultra marine only from the 1830s, could be argued to be a historic colour. It would however not enhance the 18th century character of a building built before it was available. In the same way a 'heritage' colour

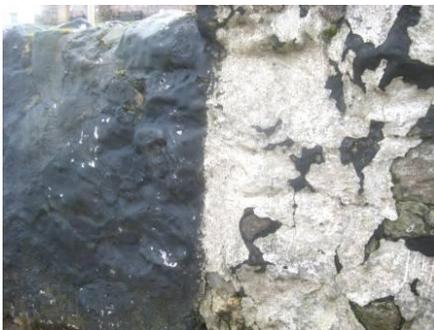
Rubble boundary wall painted in 'pitch' black and later over-coated with a lime-wash.

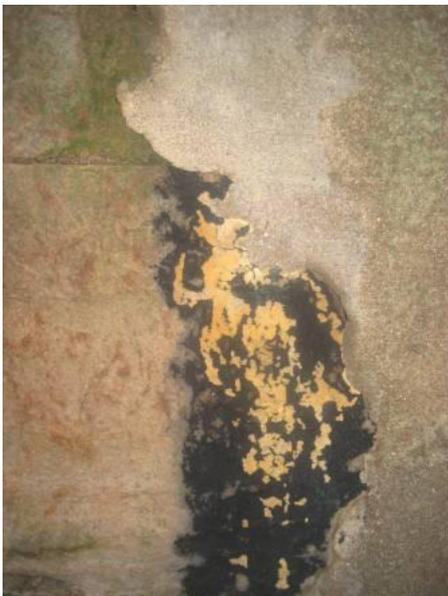
Seaward facing cottage wall with remnant of heavy uniform coating of black lime-wash with a white lime-wash later coating

Historically, on some of the more modest buildings and structures, there is even evidence that walls may have appeared black from the application of a limewash containing lamp black, possibly even mixed with tallow. The benefits would have been to better weatherproof walls and to disguise the patchy smoke grime from the many industrial and domestic fires which polluted the coastline.

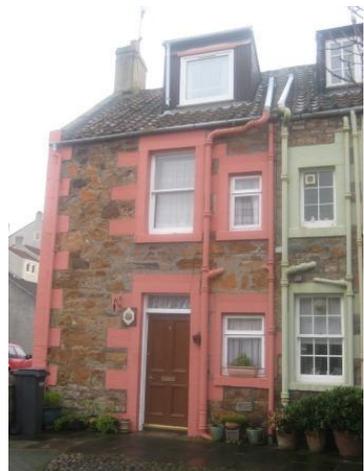
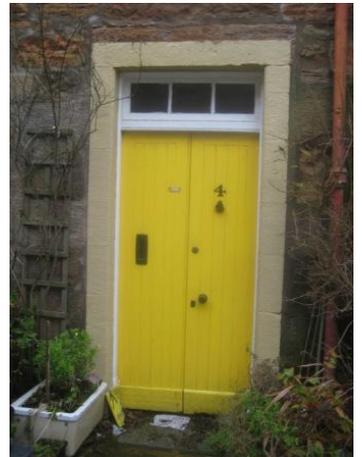
Examples above of some of the many non-traditional colours used throughout the conservation area.

Primary colours should be avoided for doors and for picking out margins although strong traditional colours in deep shades are acceptable for doors. The use of black for contrasting door and window margins is often considered traditional although there is no historic evidence.

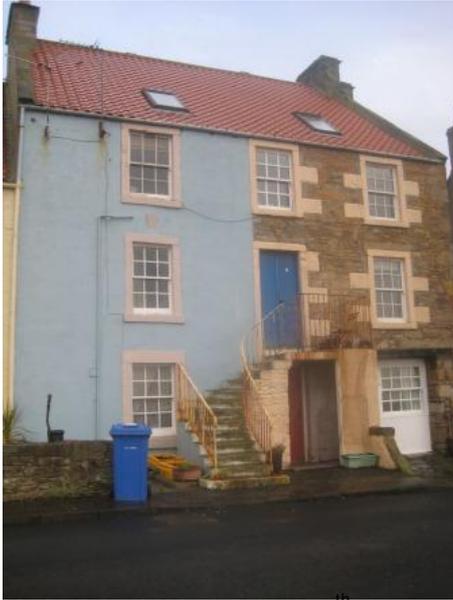
Much altered, originally late 18th century, house, East Shore. The different treatment of the two halves of the external masonry further confuses its historic character.

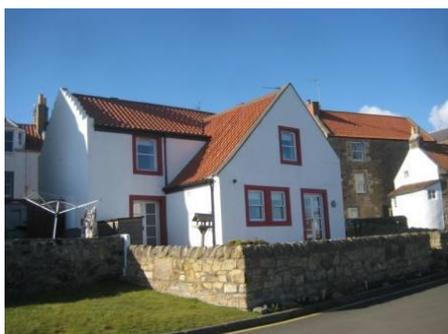
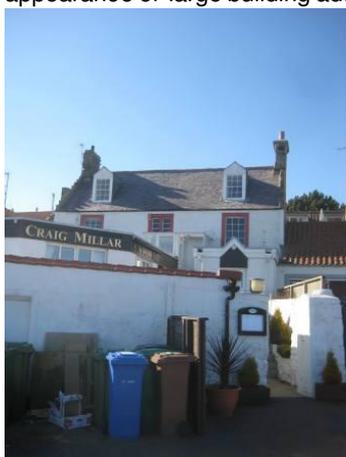
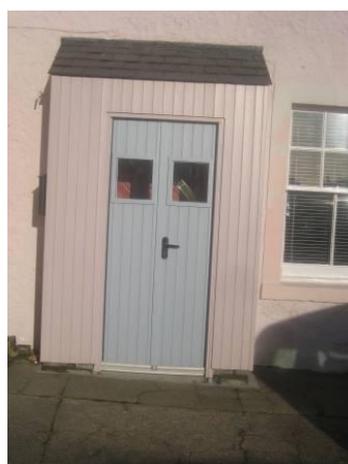
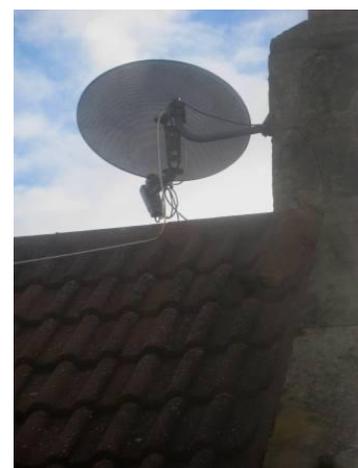
Examples above and following page of the impact on the character and appearance of large building additions.

A number of listed buildings within the conservation area have substantial additions which have significantly diminished their original 18th or 19th century character and appearance. A large number of listed buildings within the conservation area, many built in the 18th century such as 4 West Shore, appear to have had dormer windows added since listing. On a smaller scale, solar panels, satellite dishes and even TV aerials, which are clearly modern intrusions and diminish the historic character, can be seen throughout the conservation area. Even the addition of a new porch needs to be treated with care to ensure that it is sympathetic and appropriate.

Great care needs to be taken to ensure that any alterations or additions do not harm the special character and appearance of buildings and the conservation area. Some may even enhance the special character.

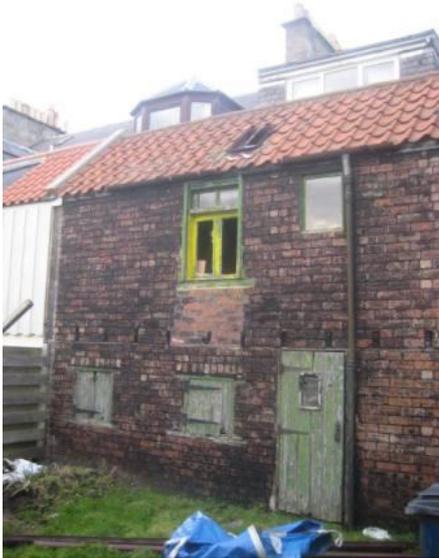
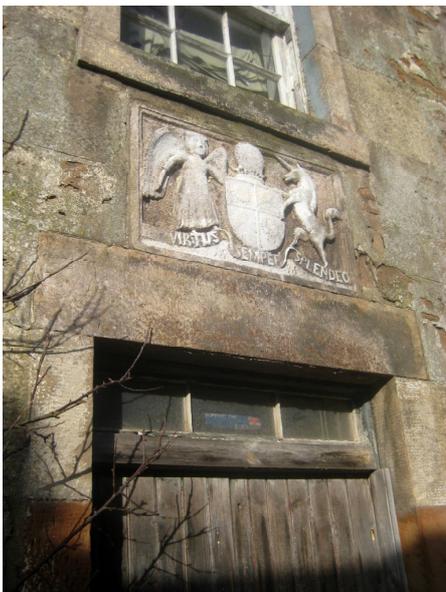
Armorial panel over front door at 26 Forth Street

There are, however, buildings or structures of historic or architectural merit which, whilst not on the register, are potentially at risk. For example, the house at 26 Forth Street appears to be that shown on the OS 1st Edition map of 1857. It is externally largely as built but in a poor condition. Particularly disfiguring is the PVC-u pipe-work which has been added recently to the north-west corner of the building. There is an unusual armorial panel over the front door which warrants investigation and may add significance to the building.

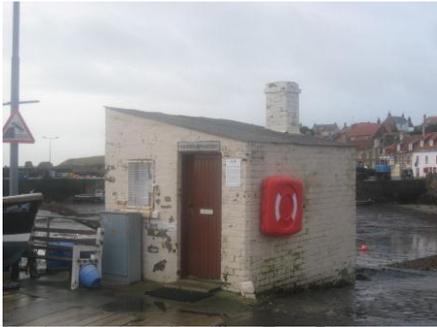
Harbourmaster's office East Pier.

remain where sheds used to stand. On the waterfront their disappearance is less noticeable, until the same scene is compared with old photographs. The major change in the character and appearance of the harbour area then becomes evident. The harbourmaster's office at the East Pier, although a modest building, is a valuable reminder of the historic harbour-related activities. Similarly a boat building yard or stable yard and buildings are important reminders of past activities.

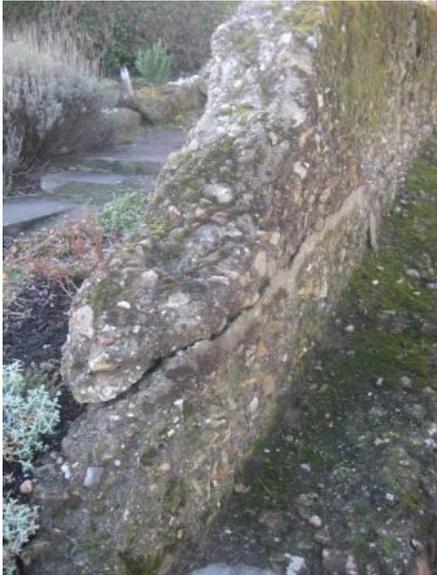
A damaged remnant of the wave wall to the west harbour pier of 1877 constructed using an early shuttered concrete technique

There is an important remnant of the old harbour wall to the west of the west harbour winch house. The Category B listed pier, built in 1878, appears to be an early example of the use of shuttered mass concrete using beach pebbles for its aggregate. Based on photographic evidence, much of the landward end of the wave wall has already been lost and what remains should be repaired and suitably protected.

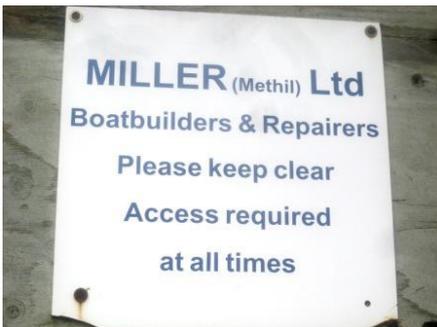
A rare reminder of the former boat-building industry .

Given the importance of ship-building in the development of and in forming the character of the conservation area, few physical reminders remain. The last surviving shed, off Virgin Square, is presently under consideration for re-development. In the more built up areas just the footprints now

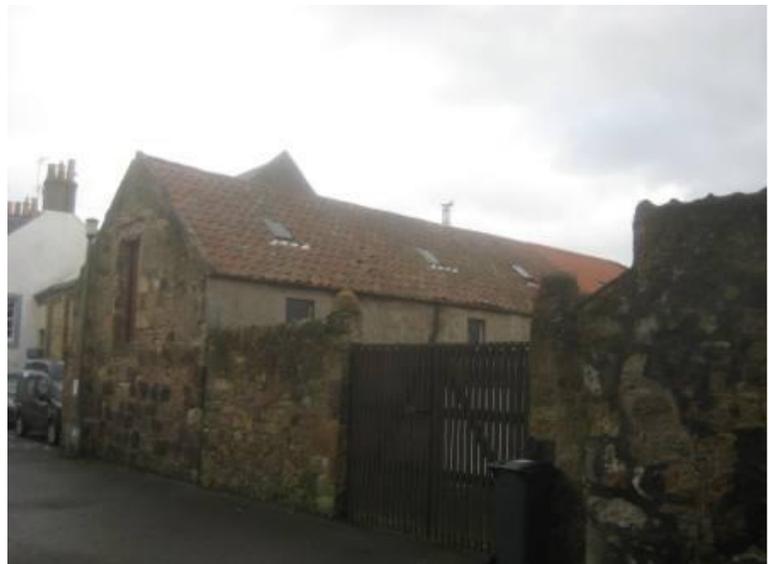
Part of the special character and appearance of the conservation area is the result of its mix of different types of building reflecting past activities even though they may now be obsolete. An example is the stable. In converting such a building to residential use the pressure is to add domestic materials and design elements to give it the character and amenities of a house. As a consequence much of the original character may be lost. There are other reminders of past, now obsolete, uses which add character which may be vulnerable to loss. For example, behind George Terrace, built circa 1890, there are rows of two storeys brick-built wash houses with storage rooms above. These storage rooms were, it is said, sometimes lived in when the best rooms in the house were let to visitors in the summer. These unusual buildings with social history significance are in generally poor condition and at risk.

Yard and stable building at end of West Street. Probably those shown on OS 1st Edition of 1855.
