**ST MONANS CONSERVATION AREA APPRAISAL
and
CONSERVATION AREA MANAGEMENT PLAN**

**ENTERPRISE, PLANNING &
PROTECTIVE SERVICES**

APPROVED JUNE 2013

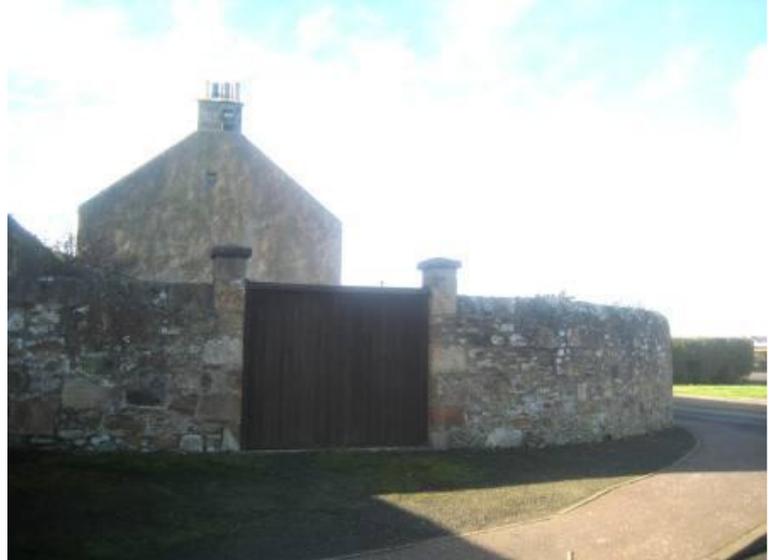
Given the importance of ship-building in the development of and in forming the character of the conservation area, few physical reminders remain. The last surviving shed, off Virgin Square, is presently under consideration for re-development. In the more built up areas just the footprints now

Former T Robertson Innes boat yard at top of Forth Street
