## WALKED ROUTE ASSESSMENT FORM

School/Educational Establishment Name	Route – write a brief description only (start/end point and key roads). <i>Attach map at end of document</i>
Inverkeithing HS	Rosyth North to Inverkeithing HS via Queensferry Road, Parkside Street, M90 underpass, A921, B981 & Boreland Road.

Date 04/02/2020	Time 0802hrs – 0840hrs
Weather Conditions Dry, cold, light (sunrise)	Key Observations Straight forward route, main roads have pedestrian crossings, all of the route has streetlighting present.

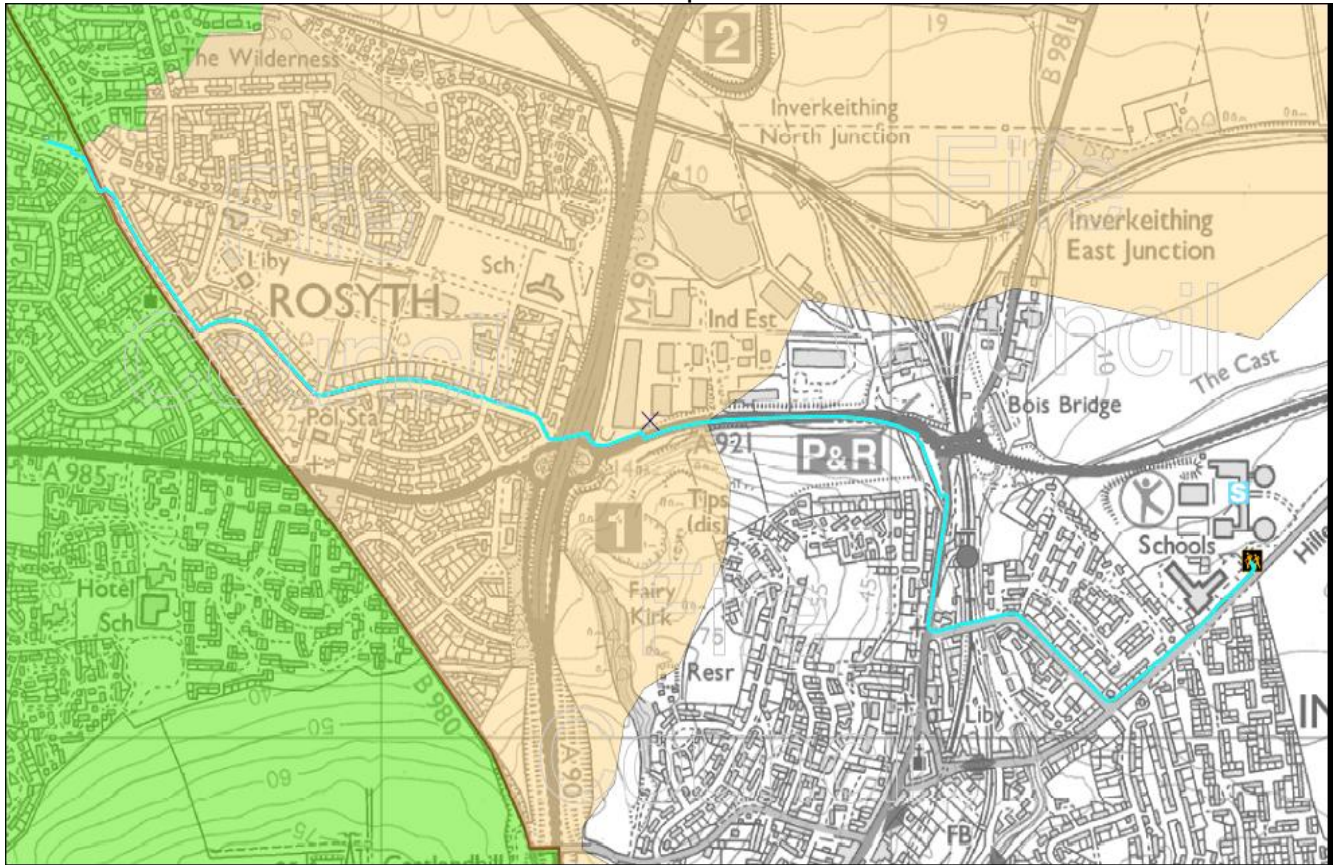
Route Map

Following the route on the map, we crossed at the following points:  
Queensferry Road  
Pedestrian crossing outside TSB bank.
