WALKED ROUTE ASSESSMENT FORM

School/Educational Establishment Name	Route – write a brief description only (start/end point and key roads). <i>Attach map at end of document</i>
Inverkeithing HS	Inverkeithing HS to Admiralty Road via Boreland Road.

Date 04/02/2020	Time 1521hrs – 1601hrs
Weather Conditions Dry, mild and Sunny	Key Observations

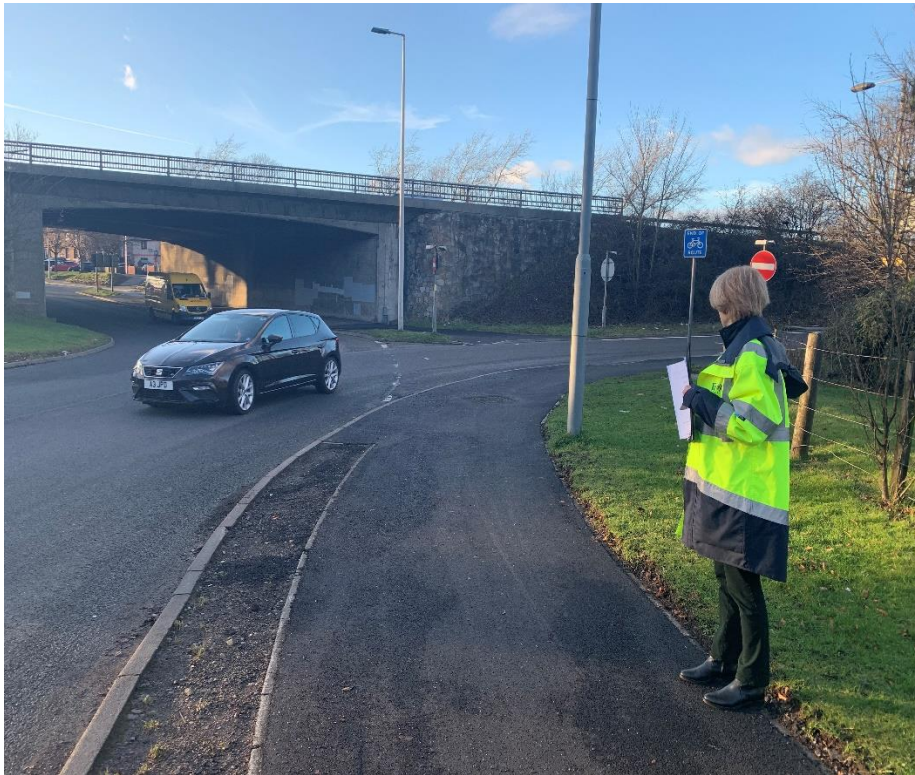
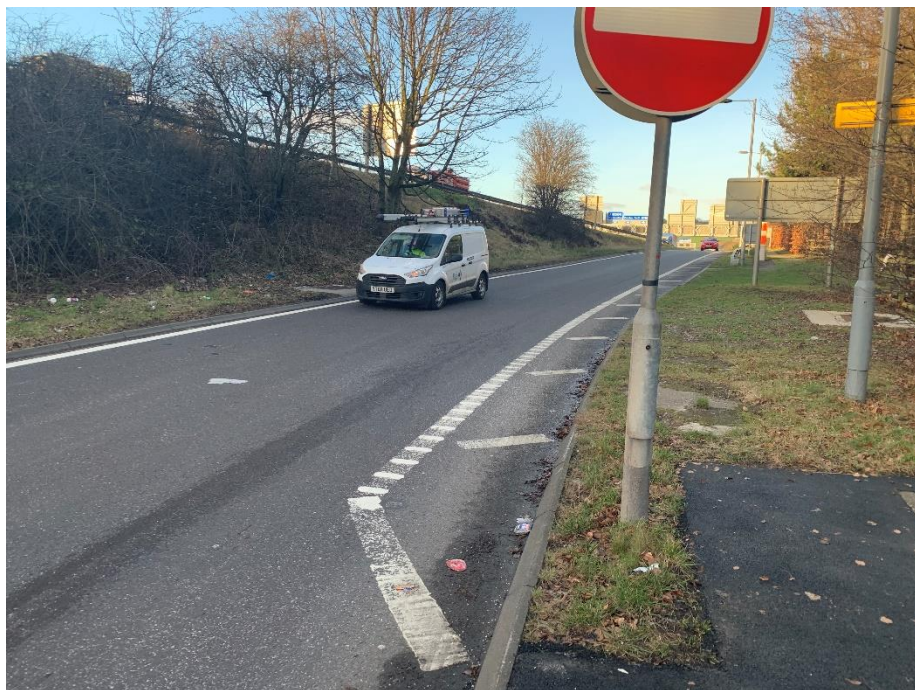
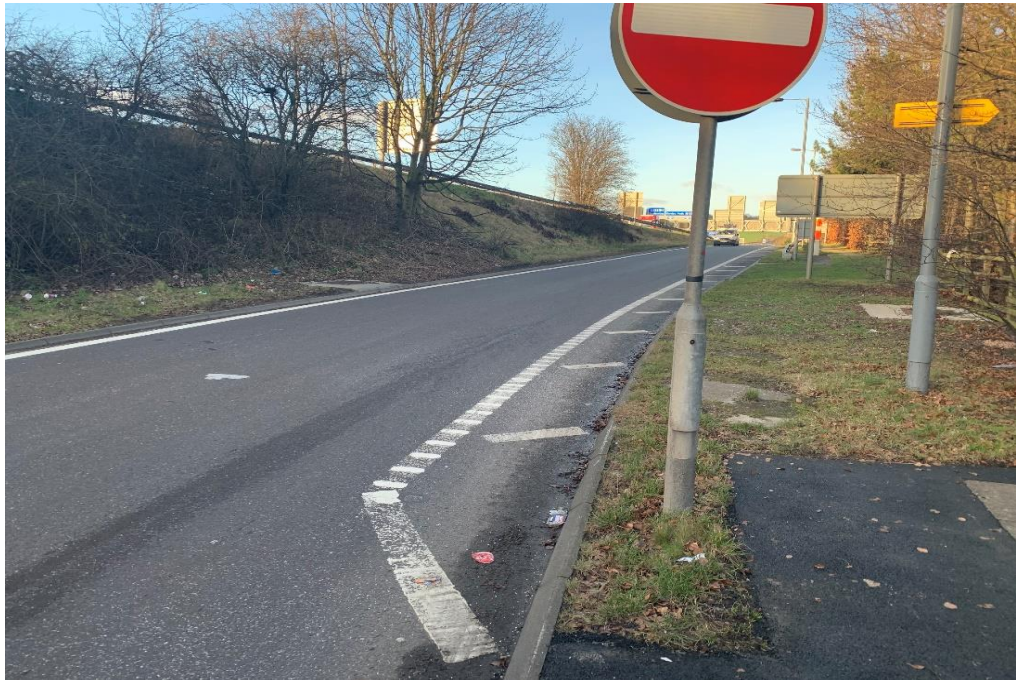
Photographs of the M90 Slip Road down to the Roundabout

It took about 10 seconds to get a gap in the traffic at the southbound off slip of the M90. Traffic here slowed down as it approached the roundabout and the sightlines were good.

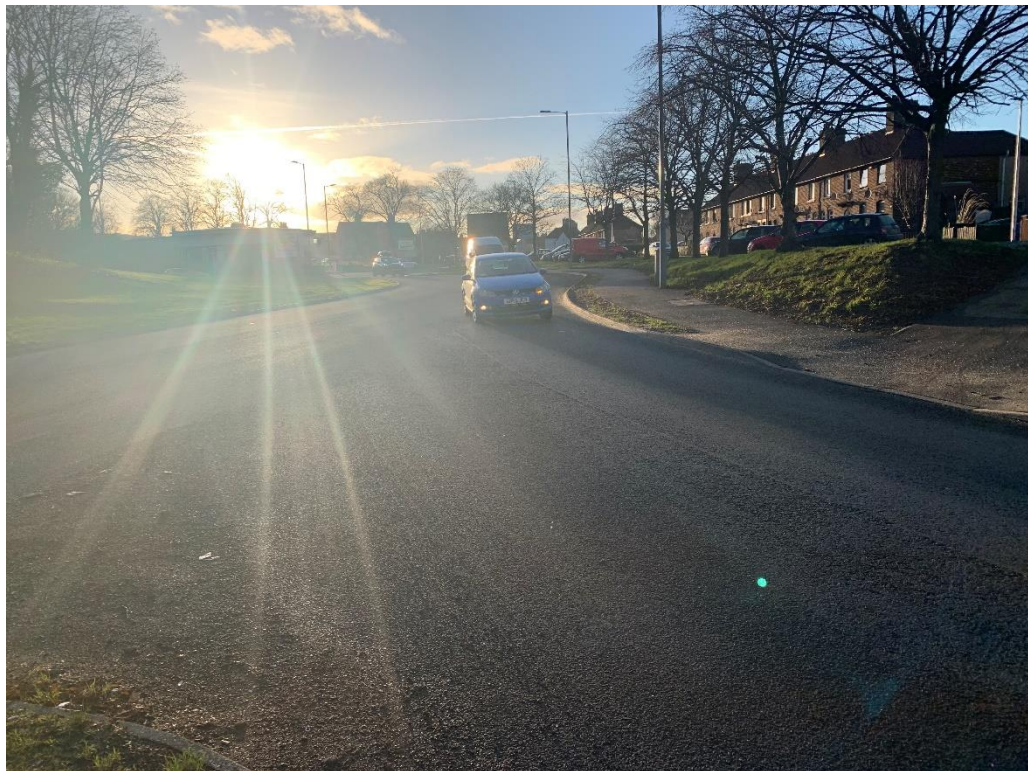
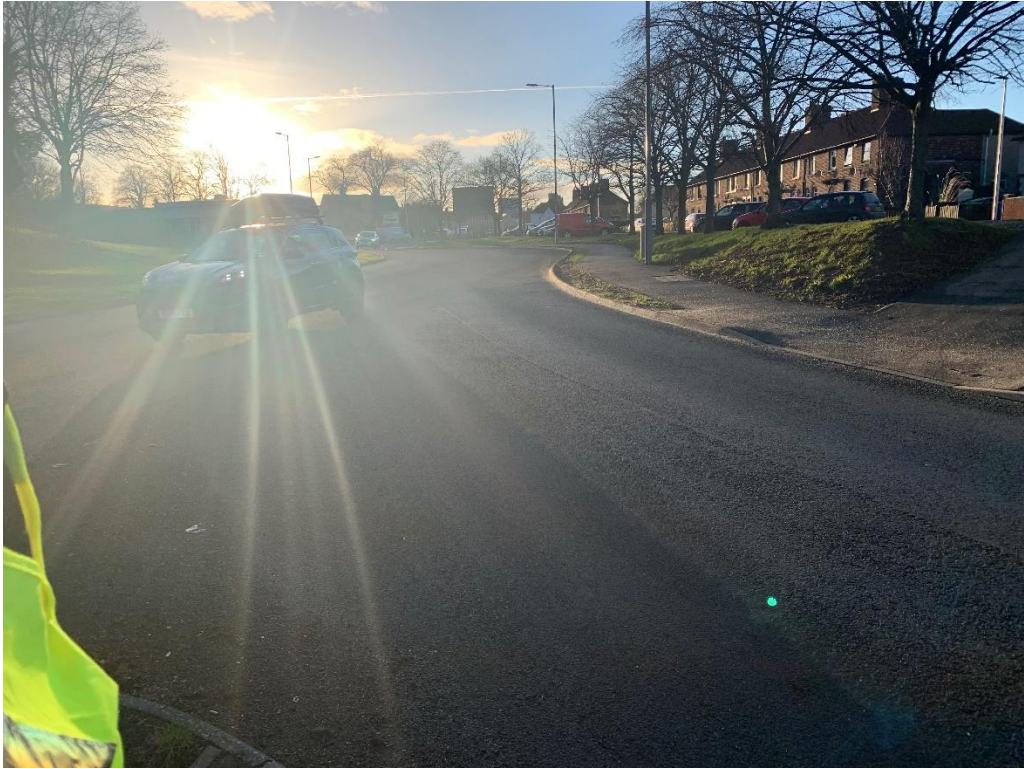
Photographs of the M90 Slip Road from the Roundabout

It took about 8 seconds to get a gap in the traffic at the northbound on slip of the M90. Traffic coming around the roundabout didn't always indicate to leave. Vehicles leaving

the roundabout tended to speed up. There were sufficient gaps but extra vigilance was needed to assess when it was appropriate to cross.

The traffic flow at the M90 slip roads was steady. At the time of the assessment there was no difficulty getting a gap in the traffic. A traffic count/gap analysis should be considered to verify the findings.

Yes. They have advised that further improvements to the roundabout are planned, but not advised that the route is unavailable. The route selected by parents/carers should be appropriate to the young person's awareness (via Admiralty Road or Castlandhill Road)
